Access Compliance Report Public Rights-of-Way (Curb Ramps)

Intersection ID: 13272 Main Street: CENTRAL_AV Cross Street: CLUB_RD Location: NE

Overall Compliance: No Severity Score: 18.75 **ADA ID: 11C4130DBA2C** Ramp Type: Perp Initial Pass/Fail: Fail

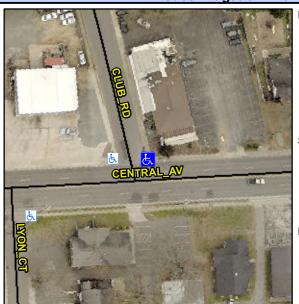
)	Possible Solutions:	<u>c</u>
į	Remove & Replace Entire Ramp.	N
á	-	N
		N/
G S		N
The state of		N
		N
	Surveyor Notes:	N
	N/A	N
		N
		N
ě		N
2	PROW/ADA:	N
	Not Found, R304.5.1, R304.5.3	N/
ı		N
ı		
		N
		N

Field Measurements/Component Compliance							
Compl	iance Description	Data	Compl	iance	Description	Data	
N/A	Ramp Length (in)	64.0	Yes	Ramp	Slope (%)	5.8	
No	Ramp Width (in)	32.0	No	Ramp	XSlope (%)	2.9	
N/A	Flare Type LT	N/A	N/A	Flare	Type RT	N/A	
N/A	Flare Slope LT (%)	N/A	N/A	Flare	Slope RT (%)	N/A	
N/A	Flare Traversable LT?	N/A	N/A	Flare	Traversable RT?	N/A	
N/A	Landing Length (in)	N/A	N/A	DWS	Provided?	N/A	
N/A	Landing Width (in)	N/A	N/A	DWS	Contrast?	N/A	
N/A	Landing Slope (%)	N/A	N/A	DWS	Length (in)	N/A	
N/A	Landing X Slope (%)	N/A	N/A	DWS	Full Width?	N/A	
N/A	Landing Curb? (Y/N)	N/A	N/A	DWS	Offset (in)	N/A	
N/A	Shared Landing?	N/A					
N/A	Gutter Ponding?	N/A	N/A	Gutte	r Slope (%)	N/A	
N/A	Gutter Lip Ht (in)	N/A	N/A	Gutte	r X Slope (%)	N/A	
N/A	Painted X Walk1?	No	N/A	Painte	ed X Walk2?	N/A	
	X Walk 1 Direction	To W		X Wa	lk 2 Direction	N/A	
N/A	X Walk 1 Width (in)	N/A	N/A	X Wa	lk 2 Width (in)	N/A

X Walk 1 Slope (%)	0.6		X Wa	lk 2 Slope (%)	N/A	
	X Walk 1 X Slope (%)	1.4		X Wa	lk 2 X Slope (%)	N/A	
N/A	Ramp inside XWalk1?	N/A	N/A	Ramp	inside XWalk2?	N/A	
	Road Slope (%)	N/A	N/A	Clear	Space?	N/A	
	Road X Slope (%)	N/A	N/A	Clear	Space to XWalk (in)	N/A	
N/A	Any Obstructions?	N/A	N/A	Storm	Grate/Utility Hazard?	N/A	
	Obstruction Type			Storm	Grate/Utility Type		
		N/A				N/A	
			Yes	Surfa	ce Condition? (G/P)	Good	
ŧ	* 11.
