Access Compliance Report Public Rights-of-Way (Curb Ramps)

Intersection ID: 47138 Main Street: SAVANNAH_HILLS_DR Cross Street: HABITAT_MANOR_DR Location: S

ADA ID: 11C91D4B6CB9 Ramp Type: BlendTrans1 Initial Pass/Fail: Fail Overall Compliance: No Severity Score: 12.5

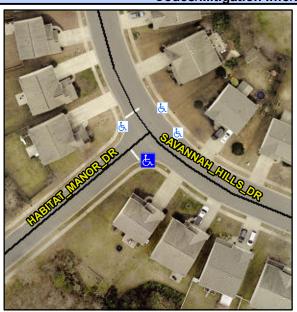
CURB GAP 2.0

Not Found, R304.5.3

Compliance Description Data Compliance Description Data Yes N/A Ramp Length (in) 49.5 BlendTrans Slope (%) 2.7 No Yes Ramp Width (in) 57.5 BlendTrans XSlope (%) 5.1 N/A N/A Flare Type LT N/A Flare Type RT N/A N/A Flare Slope LT (%) N/A N/A Flare Slope RT (%) N/A N/A Flare Traversable LT? N/A N/A Flare Traversable RT? N/A N/A Landing Length (in) N/A N/A **DWS Provided?** N/A N/A Landing Width (in) N/A N/A **DWS Contrast?** N/A N/A N/A N/A Landing Slope (%) DWS Length (in) N/A N/A Landing X Slope (%) N/A N/A DWS Full Width? N/A N/A Landing Curb? (Y/N) N/A N/A DWS Offset (in) N/A N/A N/A Shared Landing? N/A **Gutter Ponding?** N/A N/A Gutter Slope (%) N/A N/A Gutter Lip Ht (in) N/A N/A Gutter X Slope (%) N/A N/A Painted X Walk1? No N/A Painted X Walk2? No X Walk 1 Direction To NE X Walk 2 Direction To NW N/A X Walk 1 Width (in) X Walk 2 Width (in) N/A X Walk 1 Slope (%) 2.3 X Walk 2 Slope (%) 1.9 X Walk 1 X Slope (%) 0.5 X Walk 2 X Slope (%) 6.9 N/A N/A Ramp inside XWalk2? N/A N/A Ramp inside XWalk1? Road Slope (%) 3.7 Clear Space? N/A Road X Slope (%) 2.6 N/A Clear Space to XWalk (in) N/A N/A N/A N/A Any Obstructions? Storm Grate/Utility Hazard? N/A **Obstruction Type** Storm Grate/Utility Type N/A N/A Yes Surface Condition? (G/P) Good

Remove & Replace Curb Ramp With Two New Directional Ramps or Equivalent.
