Access Compliance Report Public Rights-of-Way (Curb Ramps)

Intersection ID: 10018239 Main Street: BERRY_MILLER_CT Cross Street: N/A Location: SE

ADA ID: 11CA2A58EA14 Ramp Type: Perp Initial Pass/Fail: Pass Overall Compliance: No Severity Score: 5

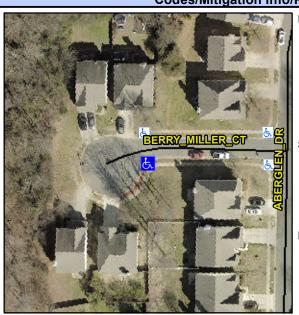
Field Measurements/Component Compliance					
Compliance Description		Data	Comp	oliance Description	Data
N/A	Ramp Length (in)	48.0	Yes	Ramp Slope (%)	8.0
Yes	Ramp Width (in)	49.0	Yes	Ramp XSlope (%)	0.8
N/A	Flare Type LT	Sloped	N/A	Flare Type RT	N/A
N/A	Flare Slope LT (%)	3.8	N/A	Flare Slope RT (%)	6.6
N/A	Flare Traversable LT?	No	N/A	Flare Traversable RT?	No
No	Landing Length (in)	46.5	Yes	DWS Provided?	Yes
Yes	Landing Width (in)	91.0	Yes	DWS Contrast?	Yes
No	Landing Slope (%)	3.8	Yes	DWS Length (in)	24.0
Yes	Landing X Slope (%)	0.7	Yes	DWS Full Width?	Yes
N/A	Landing Curb? (Y/N)	No	No	DWS Offset (in)	2.5
N/A	Shared Landing?	No			
No	Gutter Ponding?	Yes	No	Gutter Slope (%)	7.2
Yes	Gutter Lip Ht (in)	0.0	Yes	Gutter X Slope (%)	0.5
N/A	Painted X Walk1?	No	N/A	Painted X Walk2?	N/A
	X Walk 1 Direction	To N		X Walk 2 Direction	N/A
N/A	X Walk 1 Width (in)	N/A	N/A	X Walk 2 Width (in)	N/A
	X Walk 1 Slope (%)	2.9		X Walk 2 Slope (%)	N/A

X Walk 1 X Slope (%)	3.7		X Walk 2 X Slope (%)	N/A
N/A	Ramp inside XWalk1?	N/A	N/A	Ramp inside XWalk2?	N/A
	Road Slope (%)	N/A	N/A	Clear Space?	Yes
	Road X Slope (%)	N/A	N/A	Clear Space to XWalk (in)	N/A
Yes	Any Obstructions?	No	Yes	Storm Grate/Utility Hazard?	No
	Obstruction Type			Storm Grate/Utility Type	
		N/A			N/A
			Yes	Surface Condition? (G/P)	Good
1000	* 4

Possible Solutions:

Remove & Replace Entire Ramp.
Remove & Replace Gutter.
