# Access Compliance Report

## Public Rights-of-Way

### (Curb Ramps)

| Intersection ID: 3105 | Main Street: DEARMON_RD | Cross Street: BROWNE_RD | Location: | NW |

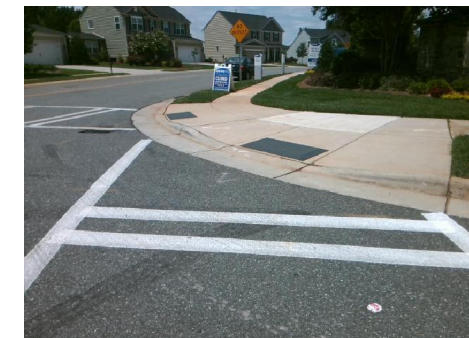
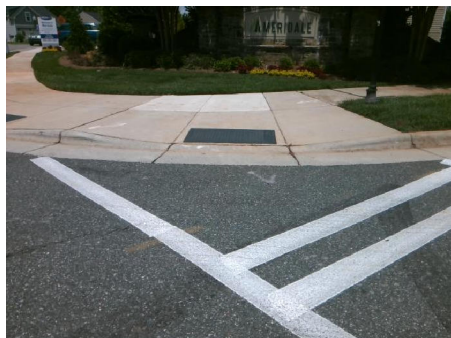
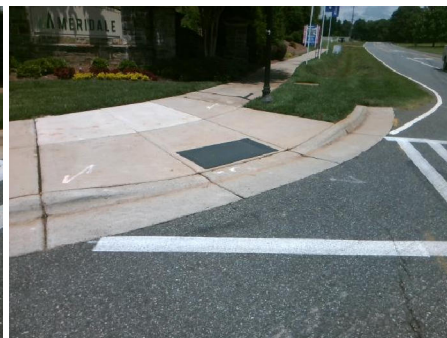
| ADA ID: 11D1B659B00E | Ramp Type: Perp | Initial Pass/Fail: Fail | Overall Compliance: No | Severity Score: 25 |

**R304.2.2**

| Compliance | Description | Data | Compliance | Description | Data |
|---|---|---|---|---|---|
| N/A | Ramp Length (in) | 62.5 | No | Ramp Slope (%) | 20.0 |

**Remove & Replace Entire Ramp.**

**\$ 1850.00**
