Access Compliance Report

Public Rights-of-Way

(Curb Ramps)

Intersection ID: 46303	Main Street: HONEY_CREEK_LN	Cross Street: MERMANS_RD	Location: NW
ADA ID: 11D32228EB95	Ramp Type: Perp	Initial Pass/Fail: Fail	Overall Compliance: No
Severity Score: 22.5			
Codes/Mitigation Info/Possible Solution		Field Measurements/Component Compliance

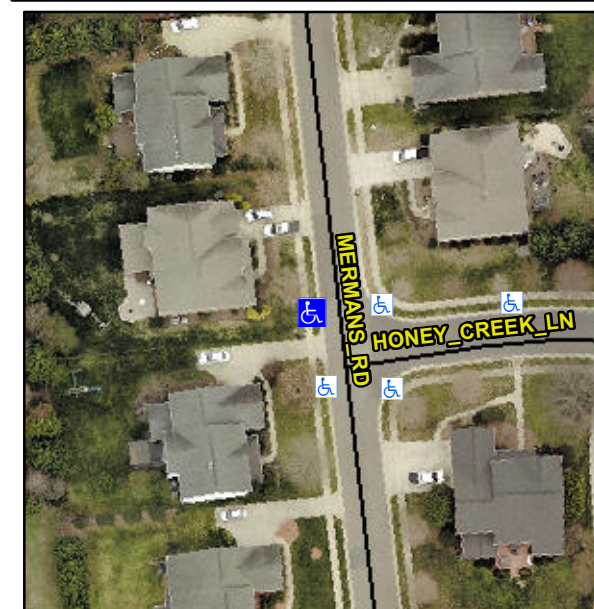
Not Found, R304.5.1, R304.2.2, R304.5.3

Compliance	Description	Data	Compliance	Description	Data
N/A	Ramp Length (in)	47.0	No	Ramp Slope (%)	8.4
No	Ramp Width (in)	47.0	No	Ramp XSlope (%)	2.6
N/A	Flare Type LT	N/A	N/A	Flare Type RT	N/A
N/A	Flare Slope LT (%)	N/A	N/A	Flare Slope RT (%)	N/A
N/A	Flare Traversable LT?	N/A	N/A	Flare Traversable RT?	N/A
N/A	Landing Length (in)	N/A	N/A	DWS Provided?	N/A
N/A	Landing Width (in)	N/A	N/A	DWS Contrast?	N/A
N/A	Landing Slope (%)	N/A	N/A	DWS Length (in)	N/A
N/A	Landing X Slope (%)	N/A	N/A	DWS Full Width?	N/A
N/A	Landing Curb? (Y/N)	N/A	N/A	DWS Offset (in)	N/A
N/A	Shared Landing?	N/A			
N/A	Gutter Ponding?	N/A	N/A	Gutter Slope (%)	N/A
N/A	Gutter Lip Ht (in)	N/A	N/A	Gutter X Slope (%)	N/A
N/A	Painted X Walk1?	No	N/A	Painted X Walk2?	N/A
	X Walk 1 Direction	To E		X Walk 2 Direction	N/A
N/A	X Walk 1 Width (in)	N/A	N/A	X Walk 2 Width (in)	N/A
	X Walk 1 Slope (%)	4.1		X Walk 2 Slope (%)	N/A
	X Walk 1 X Slope (%)	0.7		X Walk 2 X Slope (%)	N/A

N/A	Ramp inside XWalk1?	N/A	N/A	Ramp inside XWalk2?	N/A
	Road Slope (%)	N/A	N/A	Clear Space?	N/A
	Road X Slope (%)	N/A	N/A	Clear Space to XWalk (in)	N/A
N/A	Any Obstructions?	N/A	N/A	Storm Grate/Utility Hazard?	N/A
	Obstruction Type			Storm Grate/Utility Type	
		N/A			N/A
			Yes	Surface Condition? (G/P)	Good

Possible Solutions:

Remove & Replace Entire Ramp.
