Access Compliance Report

Public Rights-of-Way

(Curb Ramps)

Intersection ID: 3964	Main Street: GALLOWAY_RD	Cross Street: PARKLEIGH_DR	Location:	E
ADA ID: 11D728BCF47E	Ramp Type: PerpDiag	Initial Pass/Fail: Fail	Overall Compliance: No	Severity Score: 35

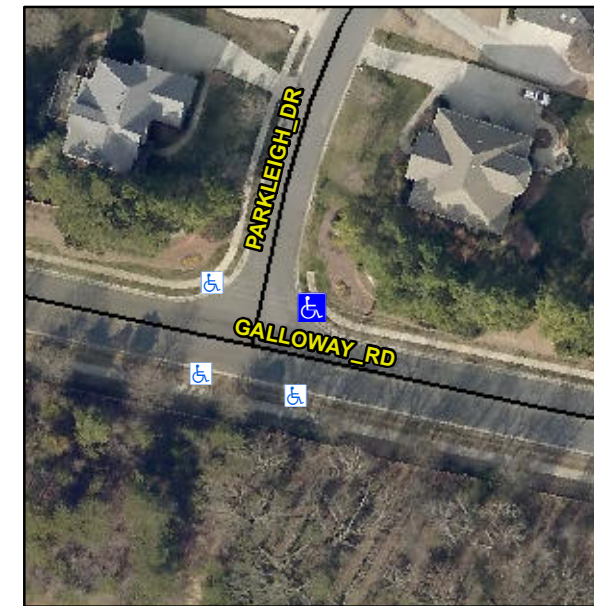
Compliance	Description	Data	Compliance	Description	Data
N/A	Ramp Length (in)	47.0	No	Ramp Slope (%)	14.1
No	Ramp Width (in)	42.0	No	Ramp XSlope (%)	3.2
N/A	Flare Type LT	N/A	N/A	Flare Type RT	N/A
N/A	Flare Slope LT (%)	N/A	N/A	Flare Slope RT (%)	N/A
N/A	Flare Traversable LT?	N/A	N/A	Flare Traversable RT?	N/A
N/A	Landing Length (in)	N/A	N/A	DWS Provided?	N/A
N/A	Landing Width (in)	N/A	N/A	DWS Contrast?	N/A
N/A	Landing Slope (%)	N/A	N/A	DWS Length (in)	N/A
N/A	Landing X Slope (%)	N/A	N/A	DWS Full Width?	N/A
N/A	Landing Curb? (Y/N)	N/A	N/A	DWS Offset (in)	N/A
N/A	Shared Landing?	N/A			
N/A	Gutter Ponding?	N/A	N/A	Gutter Slope (%)	N/A
N/A	Gutter Lip Ht (in)	N/A	N/A	Gutter X Slope (%)	N/A
N/A	Painted X Walk1?	No	N/A	Painted X Walk2?	No
	X Walk 1 Direction	To NW		X Walk 2 Direction	To SW
N/A	X Walk 1 Width (in)	N/A	N/A	X Walk 2 Width (in)	N/A
	X Walk 1 Slope (%)	2.2		X Walk 2 Slope (%)	2.5
	X Walk 1 X Slope (%)	2.4		X Walk 2 X Slope (%)	1.4

N/A	Ramp inside XWalk1?	N/A	N/A	Ramp inside XWalk2?	N/A
	Road Slope (%)	3.1	N/A	Clear Space?	N/A
	Road X Slope (%)	0.9	N/A	Clear Space to XWalk (in)	N/A
N/A	Any Obstructions?	N/A	N/A	Storm Grate/Utility Hazard?	N/A
	Obstruction Type			Storm Grate/Utility Type	
		N/A			N/A
			Yes	Surface Condition? (G/P)	Good

Remove & Replace Curb Ramp With Two New Directional Ramps or Equivalent.
