Access Compliance Report

Public Rights-of-Way

(Curb Ramps)

Intersection ID: 52931	Main Street: WALTHAM_LN	Cross Street: GRAY_OAK_LN	Location: W
ADA ID: 11D9F1631046	Ramp Type: Perp	Initial Pass/Fail: Fail	Overall Compliance: No
Severity Score: 10			
Codes/Mitigation Info/Possible Solution		Field Measurements/Component Compliance

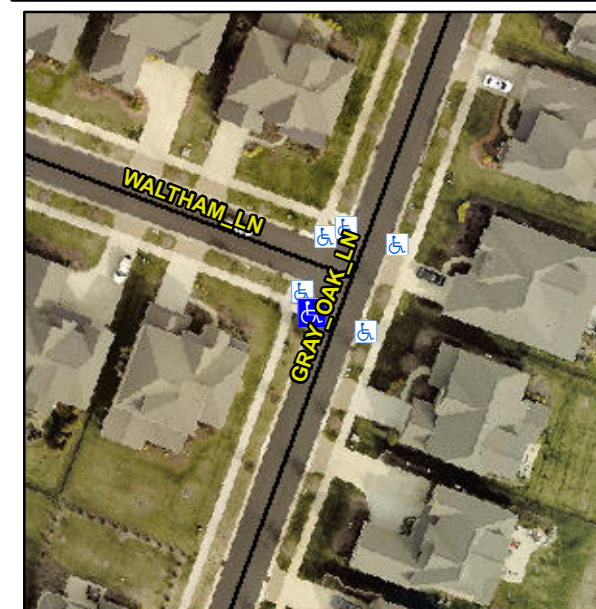
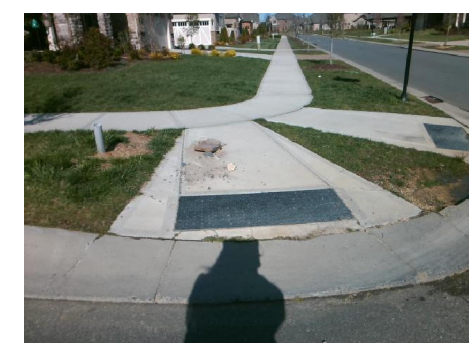
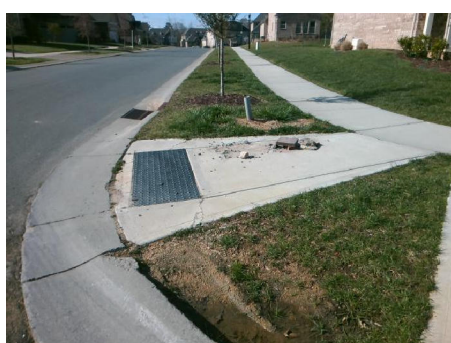
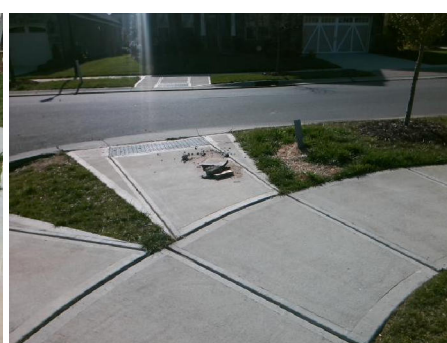
Compliance	Description	Data	Compliance	Description	Data
N/A	Ramp Length (in)	124.0	Yes	Ramp Slope (%)	8.0
No	Ramp Width (in)	47.0	No	Ramp XSlope (%)	3.2
N/A	Flare Type LT	N/A	N/A	Flare Type RT	N/A
N/A	Flare Slope LT (%)	N/A	N/A	Flare Slope RT (%)	N/A
N/A	Flare Traversable LT?	N/A	N/A	Flare Traversable RT?	N/A
N/A	Landing Length (in)	N/A	N/A	DWS Provided?	N/A
N/A	Landing Width (in)	N/A	N/A	DWS Contrast?	N/A
N/A	Landing Slope (%)	N/A	N/A	DWS Length (in)	N/A
N/A	Landing X Slope (%)	N/A	N/A	DWS Full Width?	N/A
N/A	Landing Curb? (Y/N)	N/A	N/A	DWS Offset (in)	N/A
N/A	Shared Landing?	N/A			
N/A	Gutter Ponding?	N/A	N/A	Gutter Slope (%)	N/A
N/A	Gutter Lip Ht (in)	N/A	N/A	Gutter X Slope (%)	N/A
N/A	Painted X Walk1?	No	N/A	Painted X Walk2?	N/A
	X Walk 1 Direction	To SE		X Walk 2 Direction	N/A
N/A	X Walk 1 Width (in)	N/A	N/A	X Walk 2 Width (in)	N/A
	X Walk 1 Slope (%)	4.5		X Walk 2 Slope (%)	N/A
	X Walk 1 X Slope (%)	2.3		X Walk 2 X Slope (%)	N/A

N/A	Ramp inside XWalk1?	N/A	N/A	Ramp inside XWalk2?	N/A
	Road Slope (%)	N/A	N/A	Clear Space?	N/A
	Road X Slope (%)	N/A	N/A	Clear Space to XWalk (in)	N/A
N/A	Any Obstructions?	N/A	N/A	Storm Grate/Utility Hazard?	N/A
	Obstruction Type			Storm Grate/Utility Type	
		N/A			N/A
			Yes	Surface Condition? (G/P)	Good

Possible Solutions:

Remove & Replace Entire Ramp.

R304.5.1, R304.5.3
