Access Compliance Report

Public Rights-of-Way

(Curb Ramps)

Intersection ID: 11712	Main Street: ALLEN_ST	Cross Street: E_20TH_ST	Location: W
ADA ID: 11DF5514E96E	Ramp Type: PerpDiag	Initial Pass/Fail: Fail	Overall Compliance: No
		Severity Score: 1.25

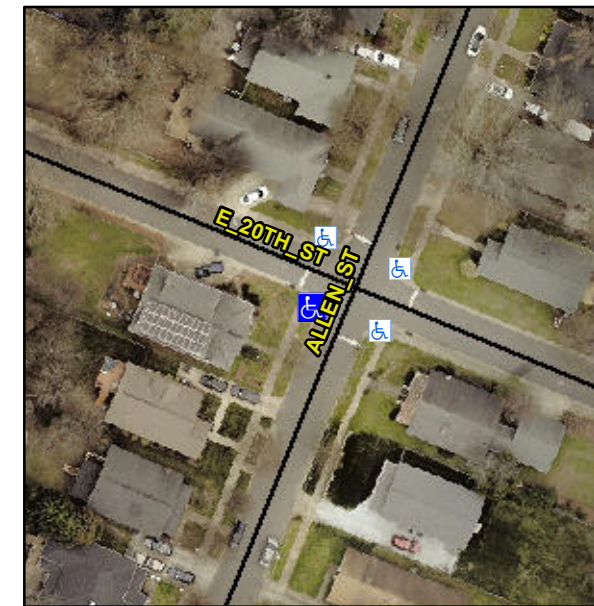
Compliance	Description	Data	Compliance	Description	Data
N/A	Ramp Length (in)	72.0	Yes	Ramp Slope (%)	6.3
Yes	Ramp Width (in)	48.0	No	Ramp XSlope (%)	4.2
N/A	Flare Type LT	N/A	N/A	Flare Type RT	N/A
N/A	Flare Slope LT (%)	N/A	N/A	Flare Slope RT (%)	N/A
N/A	Flare Traversable LT?	N/A	N/A	Flare Traversable RT?	N/A
N/A	Landing Length (in)	N/A	N/A	DWS Provided?	N/A
N/A	Landing Width (in)	N/A	N/A	DWS Contrast?	N/A
N/A	Landing Slope (%)	N/A	N/A	DWS Length (in)	N/A
N/A	Landing X Slope (%)	N/A	N/A	DWS Full Width?	N/A
N/A	Landing Curb? (Y/N)	N/A	N/A	DWS Offset (in)	N/A
N/A	Shared Landing?	N/A			
N/A	Gutter Ponding?	N/A	N/A	Gutter Slope (%)	N/A
N/A	Gutter Lip Ht (in)	0.5	N/A	Gutter X Slope (%)	N/A
N/A	Painted X Walk1?	No	N/A	Painted X Walk2?	No
	X Walk 1 Direction	To SE		X Walk 2 Direction	To NE
N/A	X Walk 1 Width (in)	N/A	N/A	X Walk 2 Width (in)	N/A
	X Walk 1 Slope (%)	4.2		X Walk 2 Slope (%)	1.1
	X Walk 1 X Slope (%)	1.3		X Walk 2 X Slope (%)	3.0

N/A	Ramp inside XWalk1?	N/A	N/A	Ramp inside XWalk2?	N/A
	Road Slope (%)	2.1	N/A	Clear Space?	N/A
	Road X Slope (%)	3.0	N/A	Clear Space to XWalk (in)	N/A
N/A	Any Obstructions?	N/A	N/A	Storm Grate/Utility Hazard?	N/A
	Obstruction Type			Storm Grate/Utility Type	
		N/A			N/A
		Yes		Surface Condition? (G/P)	Good

Remove & Replace Curb Ramp With Two New Directional Ramps or Equivalent.

Not Found, R304.5.3
