# Access Compliance Report

## Public Rights-of-Way

### (Curb Ramps)

Intersection ID: 3735	Main Street: DAVIS_LAKE_PY	Cross Street: FOXBRIAR_TL	Location: SE
ADA ID: 11EE8C5831C5	Ramp Type: Perp	Initial Pass/Fail: Fail	Overall Compliance: No
Severity Score: 13.75			
Codes/Mitigation Info/Possible Solution		Field Measurements/Component Compliance

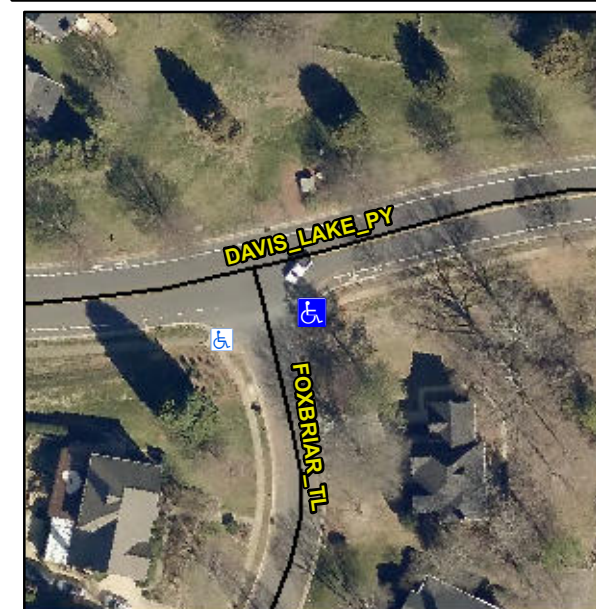
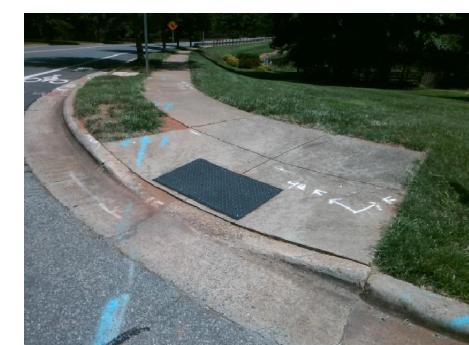
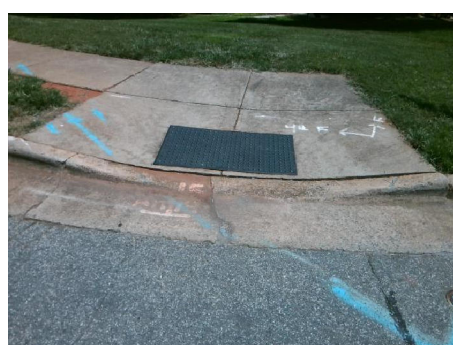
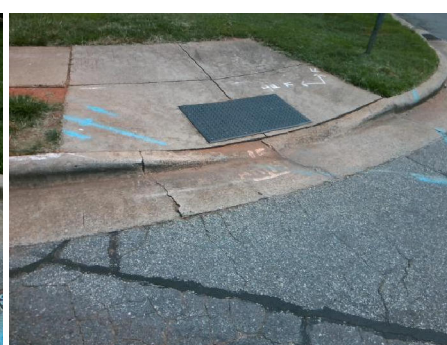
**Not Found, R304.2.2, R304.5.3**

Compliance	Description	Data	Compliance	Description	Data
N/A	Ramp Length (in)	46.0	No	Ramp Slope (%)	9.1
Yes	Ramp Width (in)	48.0	No	Ramp XSlope (%)	2.3
N/A	Flare Type LT	N/A	N/A	Flare Type RT	N/A
N/A	Flare Slope LT (%)	N/A	N/A	Flare Slope RT (%)	N/A
N/A	Flare Traversable LT?	N/A	N/A	Flare Traversable RT?	N/A
N/A	Landing Length (in)	N/A	N/A	DWS Provided?	N/A
N/A	Landing Width (in)	N/A	N/A	DWS Contrast?	N/A
N/A	Landing Slope (%)	N/A	N/A	DWS Length (in)	N/A
N/A	Landing X Slope (%)	N/A	N/A	DWS Full Width?	N/A
N/A	Landing Curb? (Y/N)	N/A	N/A	DWS Offset (in)	N/A
N/A	Shared Landing?	N/A			
N/A	Gutter Ponding?	N/A	N/A	Gutter Slope (%)	N/A
N/A	Gutter Lip Ht (in)	N/A	N/A	Gutter X Slope (%)	N/A
N/A	Painted X Walk1?	No	N/A	Painted X Walk2?	N/A
	X Walk 1 Direction	To W		X Walk 2 Direction	N/A
N/A	X Walk 1 Width (in)	N/A	N/A	X Walk 2 Width (in)	N/A
	X Walk 1 Slope (%)	4.5		X Walk 2 Slope (%)	N/A
	X Walk 1 X Slope (%)	8.2		X Walk 2 X Slope (%)	N/A

N/A	Ramp inside XWalk1?	N/A	N/A	Ramp inside XWalk2?	N/A
	Road Slope (%)	N/A	N/A	Clear Space?	N/A
	Road X Slope (%)	N/A	N/A	Clear Space to XWalk (in)	N/A
N/A	Any Obstructions?	N/A	N/A	Storm Grate/Utility Hazard?	N/A
	Obstruction Type			Storm Grate/Utility Type	
		N/A			N/A
			Yes	Surface Condition? (G/P)	Good

**Remove & Replace Entire Ramp.**
