Access Compliance Report Public Rights-of-Way (Curb Ramps)

Intersection ID: 29767 Main Street: KING_ARTHUR_DR Cross Street: MORDRED_LN Location: S

ADA ID: 11F214F1F256 Ramp Type: PerpDiag Initial Pass/Fail: Fail Overall Compliance: No Severity Score: 37.5

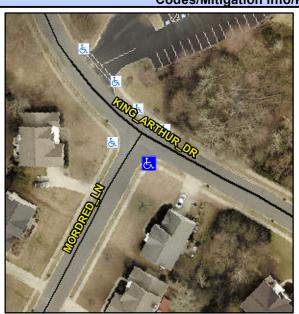
Not Found, R304.2.2, R304.5.3

Compliance Description Date		Data	Comp	liance	Description	Data
N/A	Ramp Length (in)	48.0	No	Ram	Slope (%)	9.9
Yes	Ramp Width (in)	49.0	No	Ram	XSlope (%)	11.0
N/A	Flare Type LT	N/A	N/A	Flare	Type RT	N/A
N/A	Flare Slope LT (%)	N/A	N/A	Flare	Slope RT (%)	N/A
N/A	Flare Traversable LT?	N/A	N/A	Flare	Traversable RT?	N/A
N/A	Landing Length (in)	N/A	N/A	DWS	Provided?	N/A
N/A	Landing Width (in)	N/A	N/A	DWS	Contrast?	N/A
N/A	Landing Slope (%)	N/A	N/A	DWS	Length (in)	N/A
N/A	Landing X Slope (%)	N/A	N/A	DWS	Full Width?	N/A
N/A	Landing Curb? (Y/N)	N/A	N/A	DWS	Offset (in)	N/A
N/A	Shared Landing?	N/A				
N/A	Gutter Ponding?	N/A	N/A	Gutte	er Slope (%)	N/A
N/A	Gutter Lip Ht (in)	N/A	N/A	Gutte	er X Slope (%)	N/A
N/A	Painted X Walk1?	No	N/A	Paint	ed X Walk2?	No
	X Walk 1 Direction	To NE		X Wa	lk 2 Direction	To NW
N/A	X Walk 1 Width (in)	N/A	N/A	X Wa	lk 2 Width (in)	N/A
	X Walk 1 Slope (%)	0.9		X Wa	lk 2 Slope (%)	0.8
	X Walk 1 X Slope (%)	1.5		X Wa	lk 2 X Slope (%)	3.4

N/A	Ramp inside XWalk1?	N/A	N/A	Ram	o inside XWalk2?	N/A
	Road Slope (%)	1.8	N/A	Clear	Space?	N/A
	Road X Slope (%)	0.1	N/A	Clear	Space to XWalk (in)	N/A
N/A	Any Obstructions?	N/A	N/A	Storn	n Grate/Utility Hazard?	N/A
	Obstruction Type			Storn	n Grate/Utility Type	
		N/A				N/A
			Yes	Surfa	ce Condition? (G/P)	Good

Remove & Replace Curb Ramp With Two New Directional Ramps or Equivalent.
