Intersection ID: 11027	Main Street: ELKWOOD_CR	Cross Street: SHAMROCK_DR	Location:	W
ADA ID: 11F49BDB0F2C	Ramp Type: PerpDiag	Initial Pass/Fail: Fail	Overall Compliance: No	Severity Score: 26.25

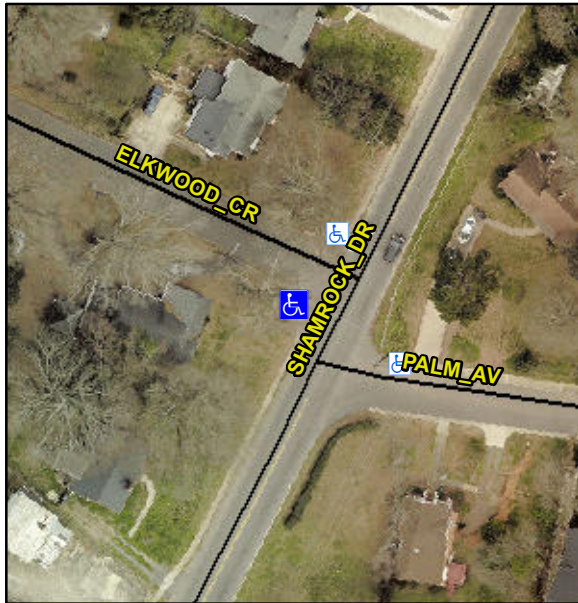
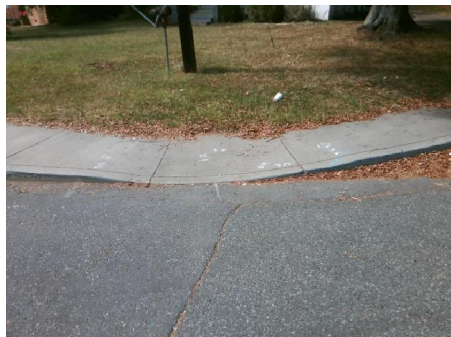
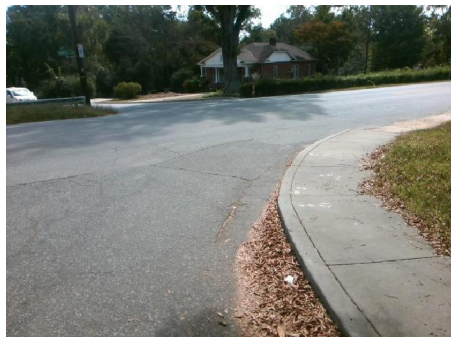
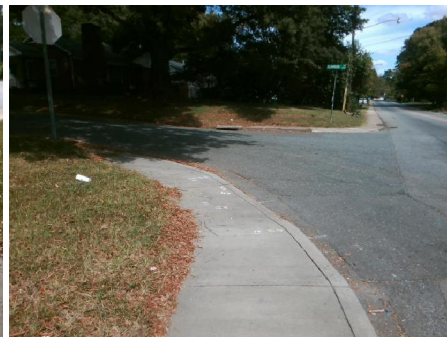
**Not Found, R304.2.2, R304.5.3**

Compliance	Description	Data	Compliance	Description	Data
N/A	Ramp Length (in)	47.5	No	Ramp Slope (%)	12.4
Yes	Ramp Width (in)	58.5	No	Ramp XSlope (%)	3.5
N/A	Flare Type LT	N/A	N/A	Flare Type RT	N/A
N/A	Flare Slope LT (%)	N/A	N/A	Flare Slope RT (%)	N/A
N/A	Flare Traversable LT?	N/A	N/A	Flare Traversable RT?	N/A
N/A	Landing Length (in)	N/A	N/A	DWS Provided?	N/A
N/A	Landing Width (in)	N/A	N/A	DWS Contrast?	N/A
N/A	Landing Slope (%)	N/A	N/A	DWS Length (in)	N/A
N/A	Landing X Slope (%)	N/A	N/A	DWS Full Width?	N/A
N/A	Landing Curb? (Y/N)	N/A	N/A	DWS Offset (in)	N/A
N/A	Shared Landing?	N/A			
N/A	Gutter Ponding?	N/A	N/A	Gutter Slope (%)	N/A
N/A	Gutter Lip Ht (in)	N/A	N/A	Gutter X Slope (%)	N/A
N/A	Painted X Walk1?	No	N/A	Painted X Walk2?	No
	X Walk 1 Direction	To SE		X Walk 2 Direction	To NE
N/A	X Walk 1 Width (in)	N/A	N/A	X Walk 2 Width (in)	N/A
	X Walk 1 Slope (%)	0.6		X Walk 2 Slope (%)	3.6
	X Walk 1 X Slope (%)	1.7		X Walk 2 X Slope (%)	1.7

N/A	Ramp inside XWalk1?	N/A	N/A	Ramp inside XWalk2?	N/A
	Road Slope (%)	3.0	N/A	Clear Space?	N/A
	Road X Slope (%)	0.4	N/A	Clear Space to XWalk (in)	N/A
N/A	Any Obstructions?	N/A	N/A	Storm Grate/Utility Hazard?	N/A
	Obstruction Type			Storm Grate/Utility Type	
		N/A			N/A
			Yes	Surface Condition? (G/P)	Good

**Remove & Replace Curb Ramp With Two New Directional Ramps or Equivalent.**
