# Access Compliance Report

## Public Rights-of-Way

Intersection ID: 22127	Main Street: OLD_PROVIDENCE_RD	Cross Street: RIVER_OAKS_LN	Location: SW
ADA ID: 11FA7B5F1465	Ramp Type: PerpDiag	Initial Pass/Fail: Fail	Overall Compliance: No
Severity Score: 85			
Codes/Mitigation Info/Possible Solution		Field Measurements/Component Compliance

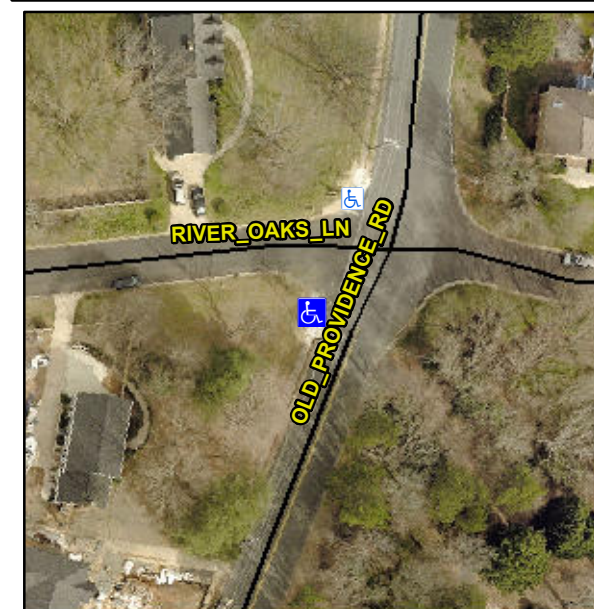
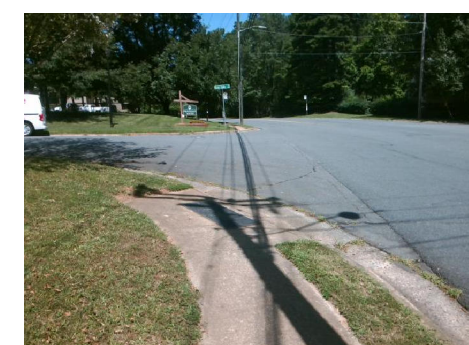
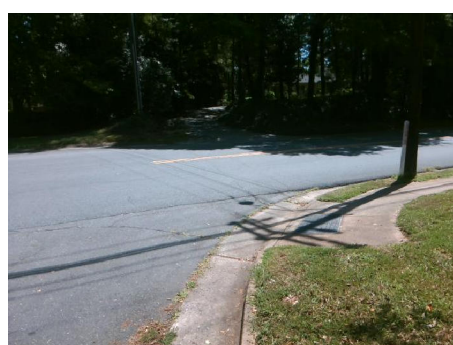
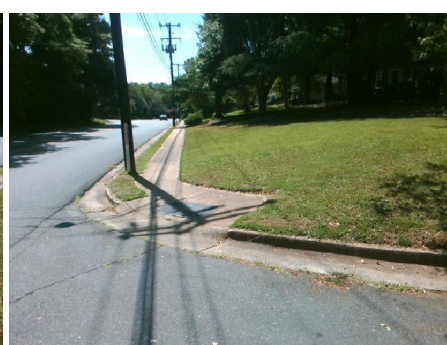
**Not Found, R304.5.1, R304.2.2, R304.5.3**

Compliance	Description	Data	Compliance	Description	Data
N/A	Ramp Length (in)	63.0	No	Ramp Slope (%)	13.2
No	Ramp Width (in)	30.5	No	Ramp XSlope (%)	7.9
N/A	Flare Type LT	N/A	N/A	Flare Type RT	N/A
N/A	Flare Slope LT (%)	N/A	N/A	Flare Slope RT (%)	N/A
N/A	Flare Traversable LT?	N/A	N/A	Flare Traversable RT?	N/A
N/A	Landing Length (in)	N/A	N/A	DWS Provided?	N/A
N/A	Landing Width (in)	N/A	N/A	DWS Contrast?	N/A
N/A	Landing Slope (%)	N/A	N/A	DWS Length (in)	N/A
N/A	Landing X Slope (%)	N/A	N/A	DWS Full Width?	N/A
N/A	Landing Curb? (Y/N)	N/A	N/A	DWS Offset (in)	N/A
N/A	Shared Landing?	N/A			
N/A	Gutter Ponding?	N/A	N/A	Gutter Slope (%)	N/A
N/A	Gutter Lip Ht (in)	N/A	N/A	Gutter X Slope (%)	N/A
N/A	Painted X Walk1?	No	N/A	Painted X Walk2?	No
	X Walk 1 Direction	To E		X Walk 2 Direction	To NE
N/A	X Walk 1 Width (in)	N/A	N/A	X Walk 2 Width (in)	N/A
	X Walk 1 Slope (%)	2.6		X Walk 2 Slope (%)	3.4
	X Walk 1 X Slope (%)	2.5		X Walk 2 X Slope (%)	1.7

N/A	Ramp inside XWalk1?	N/A	N/A	Ramp inside XWalk2?	N/A
	Road Slope (%)	3.6	N/A	Clear Space?	N/A
	Road X Slope (%)	5.1	N/A	Clear Space to XWalk (in)	N/A
N/A	Any Obstructions?	N/A	N/A	Storm Grate/Utility Hazard?	N/A
	Obstruction Type			Storm Grate/Utility Type	
		N/A			N/A
			Yes	Surface Condition? (G/P)	Good

**Remove & Replace Curb Ramp With Two New Directional Ramps or Equivalent.**
