Access Compliance Report

Public Rights-of-Way

(Curb Ramps)

Intersection ID: 28614	Main Street: KESTRAL RIDGE DR	Cross Street: WARBLER WOOD CT	Location: NW
ADA ID: 120AD8CA333D	Ramp Type: Perp	Initial Pass/Fail: Fail	Overall Compliance: No
Severity Score: 22.5			
Codes/Mitigation Info/Possible Solution		Field Measurements/Component Compliance

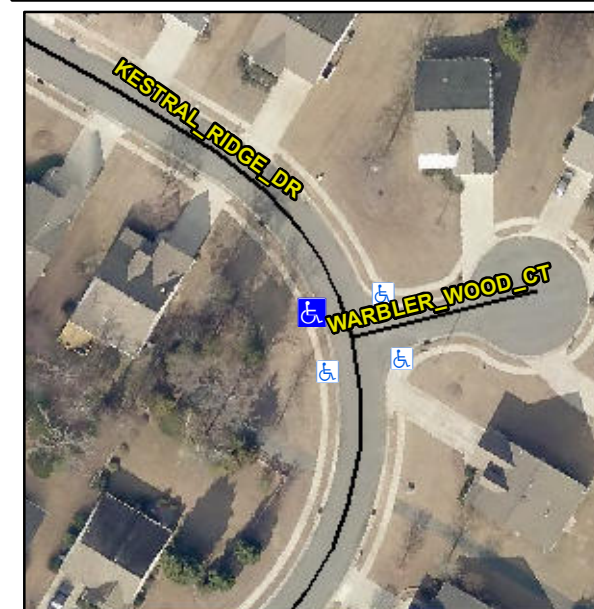
Not Found, R304.5.1, R304.2.2, R304.5.3

Compliance	Description	Data	Compliance	Description	Data
N/A	Ramp Length (in)	48.0	No	Ramp Slope (%)	10.5
No	Ramp Width (in)	46.0	No	Ramp XSlope (%)	2.9
N/A	Flare Type LT	N/A	N/A	Flare Type RT	N/A
N/A	Flare Slope LT (%)	N/A	N/A	Flare Slope RT (%)	N/A
N/A	Flare Traversable LT?	N/A	N/A	Flare Traversable RT?	N/A
N/A	Landing Length (in)	N/A	N/A	DWS Provided?	N/A
N/A	Landing Width (in)	N/A	N/A	DWS Contrast?	N/A
N/A	Landing Slope (%)	N/A	N/A	DWS Length (in)	N/A
N/A	Landing X Slope (%)	N/A	N/A	DWS Full Width?	N/A
N/A	Landing Curb? (Y/N)	N/A	N/A	DWS Offset (in)	N/A
N/A	Shared Landing?	N/A			
N/A	Gutter Ponding?	N/A	N/A	Gutter Slope (%)	N/A
N/A	Gutter Lip Ht (in)	N/A	N/A	Gutter X Slope (%)	N/A
N/A	Painted X Walk1?	No	N/A	Painted X Walk2?	N/A
	X Walk 1 Direction	To E		X Walk 2 Direction	N/A
N/A	X Walk 1 Width (in)	N/A	N/A	X Walk 2 Width (in)	N/A
	X Walk 1 Slope (%)	2.3		X Walk 2 Slope (%)	N/A
	X Walk 1 X Slope (%)	0.6		X Walk 2 X Slope (%)	N/A

N/A	Ramp inside XWalk1?	N/A	N/A	Ramp inside XWalk2?	N/A
	Road Slope (%)	N/A	N/A	Clear Space?	N/A
	Road X Slope (%)	N/A	N/A	Clear Space to XWalk (in)	N/A
N/A	Any Obstructions?	N/A	N/A	Storm Grate/Utility Hazard?	N/A
	Obstruction Type			Storm Grate/Utility Type	
		N/A			N/A
			Yes	Surface Condition? (G/P)	Good

Remove & Replace Entire Ramp.
