Access Compliance Report

Public Rights-of-Way

(Curb Ramps)

Intersection ID: 4007	Main Street: WOODFORD_BRIDGE_DR	Cross Street: BEATTIES_FORD_RD	Location: E
ADA ID: 120EDB697134	Ramp Type: Perp	Initial Pass/Fail: Pass	Overall Compliance: No
Severity Score: 11.5			
Codes/Mitigation Info/Possible Solution		Field Measurements/Component Compliance

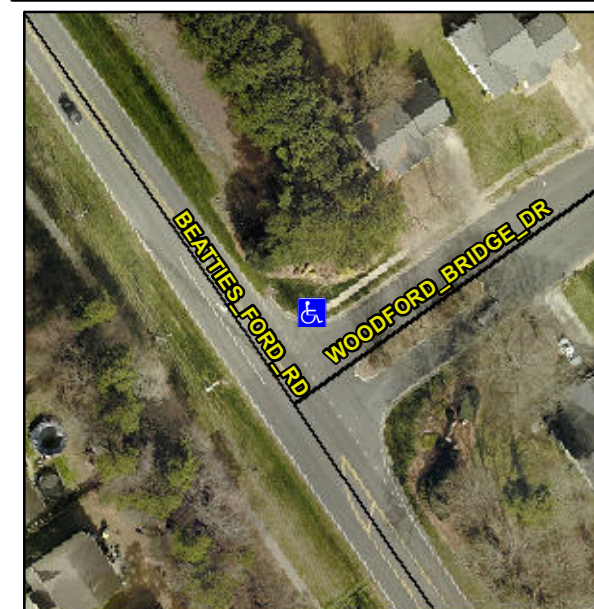
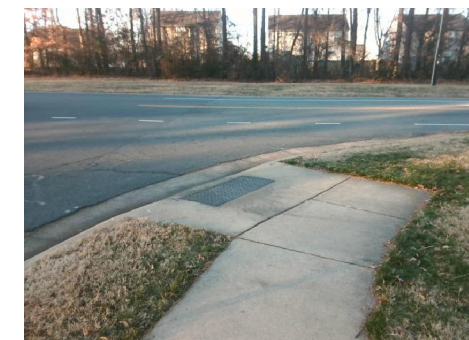
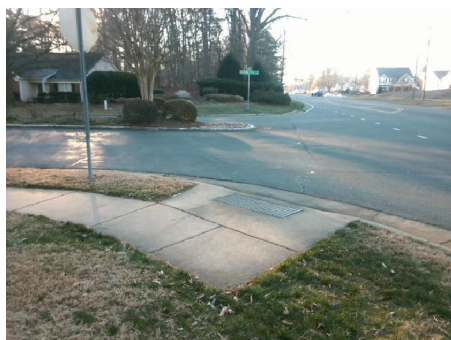
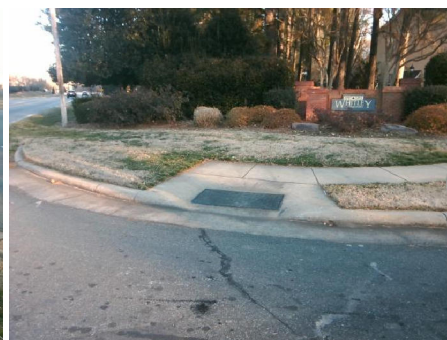
Not Found, R304.2.1, R304.2.3, R305.1.4, R305.2

Compliance	Description	Data	Compliance	Description	Data
N/A	Ramp Length (in)	50.0	Yes	Ramp Slope (%)	7.1
Yes	Ramp Width (in)	48.0	Yes	Ramp XSlope (%)	0.1
N/A	Flare Type LT	Sloped	N/A	Flare Type RT	N/A
N/A	Flare Slope LT (%)	12.9	Yes	Flare Slope RT (%)	7.6
N/A	Flare Traversable LT?	Yes	N/A	Flare Traversable RT?	Yes
No	Landing Length (in)	46.5	Yes	DWS Provided?	Yes
No	Landing Width (in)	42.0	Yes	DWS Contrast?	Yes
Yes	Landing Slope (%)	1.4	Yes	DWS Length (in)	24.0
Yes	Landing X Slope (%)	0.0	No	DWS Full Width?	No
N/A	Landing Curb? (Y/N)	No	No	DWS Offset (in)	5.0
N/A	Shared Landing?	No			
Yes	Gutter Ponding?	No	Yes	Gutter Slope (%)	1.7
Yes	Gutter Lip Ht (in)	0.0	Yes	Gutter X Slope (%)	0.8
N/A	Painted X Walk1?	No	N/A	Painted X Walk2?	N/A
	X Walk 1 Direction	To W		X Walk 2 Direction	N/A
N/A	X Walk 1 Width (in)	N/A	N/A	X Walk 2 Width (in)	N/A
	X Walk 1 Slope (%)	3.9		X Walk 2 Slope (%)	N/A
	X Walk 1 X Slope (%)	1.0		X Walk 2 X Slope (%)	N/A

N/A	Ramp inside XWalk1?	N/A	N/A	Ramp inside XWalk2?	N/A
	Road Slope (%)	N/A	N/A	Clear Space?	Yes
	Road X Slope (%)	N/A	N/A	Clear Space to XWalk (in)	N/A
Yes	Any Obstructions?	No	Yes	Storm Grate/Utility Hazard?	No
	Obstruction Type			Storm Grate/Utility Type	
		N/A			N/A
			Yes	Surface Condition? (G/P)	Good

Remove & Replace Entire Ramp.
