Access Compliance Report

Public Rights-of-Way

(Curb Ramps)

Intersection ID: 30018	Main Street: W_MALLARD_CREEK_CHURCH_RD	Cross Street: BERKELEY_PLACE_DR	Location: SE
ADA ID: 120F2742501F	Ramp Type: Perp	Initial Pass/Fail: Fail	Overall Compliance: No
Severity Score: 12.5			
Codes/Mitigation Info/Possible Solution		Field Measurements/Component Compliance

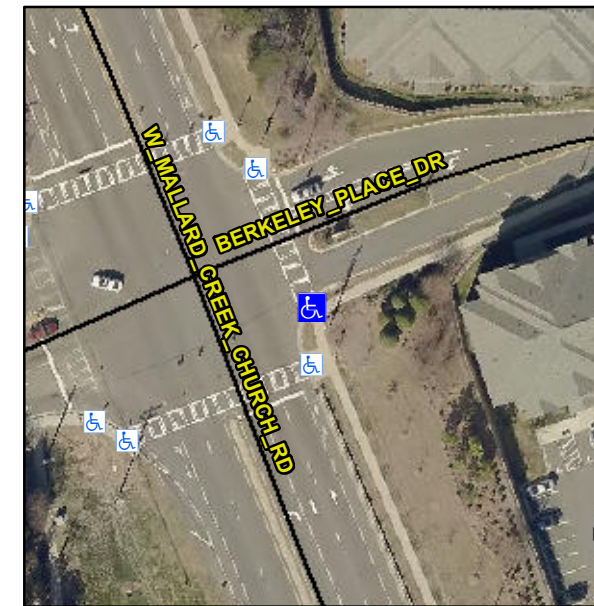
Compliance	Description	Data	Compliance	Description	Data
N/A	Ramp Length (in)	50.0	No	Ramp Slope (%)	8.6
Yes	Ramp Width (in)	48.0	Yes	Ramp XSlope (%)	1.2
N/A	Flare Type LT	N/A	N/A	Flare Type RT	N/A
N/A	Flare Slope LT (%)	N/A	N/A	Flare Slope RT (%)	N/A
N/A	Flare Traversable LT?	N/A	N/A	Flare Traversable RT?	N/A
N/A	Landing Length (in)	N/A	N/A	DWS Provided?	N/A
N/A	Landing Width (in)	N/A	N/A	DWS Contrast?	N/A
N/A	Landing Slope (%)	N/A	N/A	DWS Length (in)	N/A
N/A	Landing X Slope (%)	N/A	N/A	DWS Full Width?	N/A
N/A	Landing Curb? (Y/N)	N/A	N/A	DWS Offset (in)	N/A
N/A	Shared Landing?	N/A			
N/A	Gutter Ponding?	N/A	N/A	Gutter Slope (%)	N/A
N/A	Gutter Lip Ht (in)	N/A	N/A	Gutter X Slope (%)	N/A
N/A	Painted X Walk1?	Yes	N/A	Painted X Walk2?	N/A
	X Walk 1 Direction	To N		X Walk 2 Direction	N/A
N/A	X Walk 1 Width (in)	113.0	N/A	X Walk 2 Width (in)	N/A
	X Walk 1 Slope (%)	2.7		X Walk 2 Slope (%)	N/A
	X Walk 1 X Slope (%)	3.8		X Walk 2 X Slope (%)	N/A

N/A	Ramp inside XWalk1?	Yes	N/A	Ramp inside XWalk2?	N/A
	Road Slope (%)	N/A	N/A	Clear Space?	N/A
	Road X Slope (%)	N/A	N/A	Clear Space to XWalk (in)	N/A
N/A	Any Obstructions?	N/A	N/A	Storm Grate/Utility Hazard?	N/A
	Obstruction Type			Storm Grate/Utility Type	
		N/A			N/A
		Yes		Surface Condition? (G/P)	Good

Possible Solutions:

Remove & Replace Entire Ramp.
