## **Access Compliance Report Public Rights-of-Way** (Curb Ramps)

Intersection ID: 22038 Main Street: DELPOND LN **Cross Street: MIRABELL RD** Location: ADA ID: 1210F4269783 Ramp Type: PerpDiag Initial Pass/Fail: Fail **Overall Compliance: No** Severity Score: 21.25

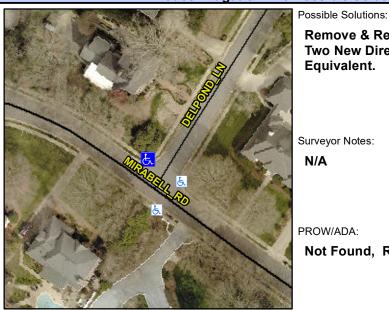
Comp	liance Description	Data	Comp	liance Description	Data
N/A	Ramp Length (in)	47.5	Yes	Ramp Slope (%)	7.4
No	Ramp Width (in)	40.0	No	Ramp XSlope (%)	6.4
N/A	Flare Type LT	N/A	N/A	Flare Type RT	N/A
N/A	Flare Slope LT (%)	N/A	N/A	Flare Slope RT (%)	N/A
N/A	Flare Traversable LT?	N/A	N/A	Flare Traversable RT?	N/A
N/A	Landing Length (in)	N/A	N/A	DWS Provided?	N/A
N/A	Landing Width (in)	N/A	N/A	DWS Contrast?	N/A
N/A	Landing Slope (%)	N/A	N/A	DWS Length (in)	N/A
N/A	Landing X Slope (%)	N/A	N/A	DWS Full Width?	N/A
N/A	Landing Curb? (Y/N)	N/A	N/A	DWS Offset (in)	N/A
N/A	Shared Landing?	N/A			
N/A	Gutter Ponding?	N/A	N/A	Gutter Slope (%)	N/A
N/A	Gutter Lip Ht (in)	N/A	N/A	Gutter X Slope (%)	N/A
N/A	Painted X Walk1?	No	N/A	Painted X Walk2?	No
	X Walk 1 Direction	To SW		X Walk 2 Direction	To SE
N/A	X Walk 1 Width (in)	N/A	N/A	X Walk 2 Width (in)	N/A
	X Walk 1 Slope (%)	1.9		X Walk 2 Slope (%)	2.9
	X Walk 1 X Slope (%)	0.3		X Walk 2 X Slope (%)	7.0

N/A	Ramp inside XWalk1?	N/A	N/A	Ramp inside XWalk2?	N/A
	Road Slope (%)	4.7	N/A	Clear Space?	N/A
	Road X Slope (%)	2.5	N/A	Clear Space to XWalk (	in) <b>N/A</b>
N/A	Any Obstructions?	N/A	N/A	Storm Grate/Utility Haz	ard? N/A
	Obstruction Type		l	Storm Grate/Utility Type	•
		N/A			N/A
			Yes	Surface Condition? (G/	P) Good

Street 1 Name Stop Condition-Street 2 Street 2 Name Stop Condition-Street 1 MIRABELL RD None **DELPOND LN** StopSign Remove & Replace Curb Ramp With Two New Directional Ramps or Equivalent.

PROW/ADA: Not Found, R304.5.1, R304.5.3 Total Cost:

3200.00
