Access Compliance Report

Public Rights-of-Way

(Curb Ramps)

Intersection ID: 13197	Main Street: S_MCDOWELL_ST	Cross Street: E_4TH_ST	Location: E
ADA ID: 12123E5A7FEA	Ramp Type: Perp	Initial Pass/Fail: Fail	Overall Compliance: No
Severity Score: 33.75			
Codes/Mitigation Info/Possible Solution		Field Measurements/Component Compliance

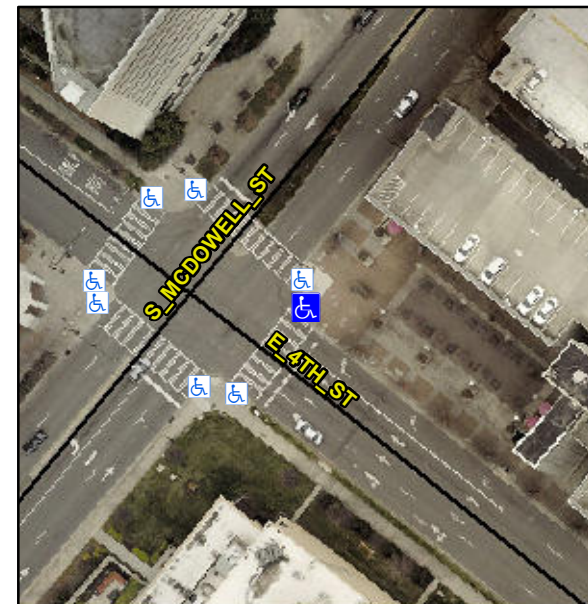
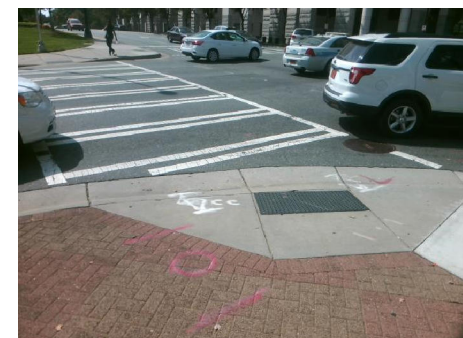
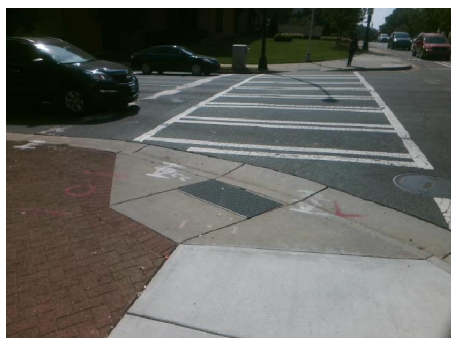
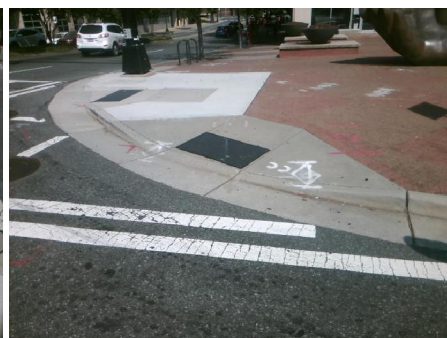
Not Found, R304.5.1, R304.2.2, R304.5.3

Compliance	Description	Data	Compliance	Description	Data
N/A	Ramp Length (in)	60.0	No	Ramp Slope (%)	10.9
No	Ramp Width (in)	46.5	No	Ramp XSlope (%)	6.5
N/A	Flare Type LT	N/A	N/A	Flare Type RT	N/A
N/A	Flare Slope LT (%)	N/A	N/A	Flare Slope RT (%)	N/A
N/A	Flare Traversable LT?	N/A	N/A	Flare Traversable RT?	N/A
N/A	Landing Length (in)	N/A	N/A	DWS Provided?	N/A
N/A	Landing Width (in)	N/A	N/A	DWS Contrast?	N/A
N/A	Landing Slope (%)	N/A	N/A	DWS Length (in)	N/A
N/A	Landing X Slope (%)	N/A	N/A	DWS Full Width?	N/A
N/A	Landing Curb? (Y/N)	N/A	N/A	DWS Offset (in)	N/A
N/A	Shared Landing?	N/A			
N/A	Gutter Ponding?	N/A	N/A	Gutter Slope (%)	N/A
N/A	Gutter Lip Ht (in)	N/A	N/A	Gutter X Slope (%)	N/A
N/A	Painted X Walk1?	Yes	N/A	Painted X Walk2?	N/A
	X Walk 1 Direction	To SW		X Walk 2 Direction	N/A
N/A	X Walk 1 Width (in)	181.0	N/A	X Walk 2 Width (in)	N/A
	X Walk 1 Slope (%)	2.2		X Walk 2 Slope (%)	N/A
	X Walk 1 X Slope (%)	4.4		X Walk 2 X Slope (%)	N/A

N/A	Ramp inside XWalk1?	Yes	N/A	Ramp inside XWalk2?	N/A
	Road Slope (%)	N/A	N/A	Clear Space?	N/A
	Road X Slope (%)	N/A	N/A	Clear Space to XWalk (in)	N/A
N/A	Any Obstructions?	N/A	N/A	Storm Grate/Utility Hazard?	N/A
	Obstruction Type			Storm Grate/Utility Type	
		N/A			N/A
			Yes	Surface Condition? (G/P)	Good

Possible Solutions:

Remove & Replace Entire Ramp.
