Access Compliance Report

Public Rights-of-Way

(Curb Ramps)

Intersection ID: 21992	Main Street: WESTINGHOUSE_BV	Cross Street: S_TRYON_ST	Location: NW
ADA ID: 1213C7CD213D	Ramp Type: Perp	Initial Pass/Fail: Fail	Overall Compliance: No
Severity Score: 22.5			
Codes/Mitigation Info/Possible Solution		Field Measurements/Component Compliance

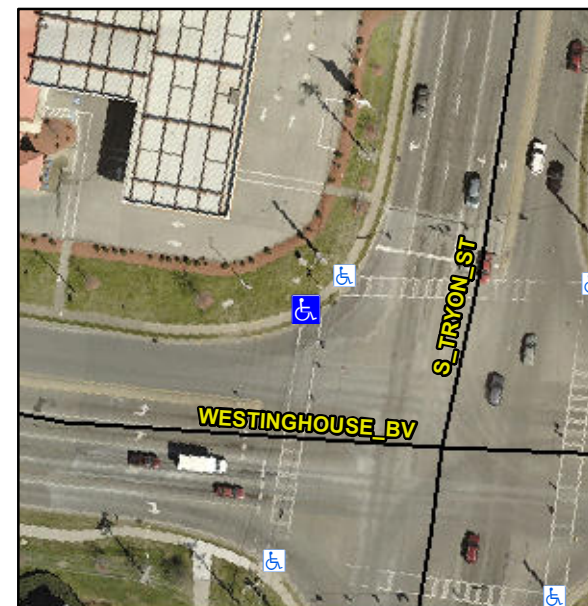
R304.5.1, R304.2.2

Compliance	Description	Data	Compliance	Description	Data
N/A	Ramp Length (in)	89.0	No	Ramp Slope (%)	9.1
No	Ramp Width (in)	44.0	Yes	Ramp XSlope (%)	2.2
N/A	Flare Type LT	N/A	N/A	Flare Type RT	N/A
N/A	Flare Slope LT (%)	N/A	N/A	Flare Slope RT (%)	N/A
N/A	Flare Traversable LT?	N/A	N/A	Flare Traversable RT?	N/A
N/A	Landing Length (in)	N/A	N/A	DWS Provided?	N/A
N/A	Landing Width (in)	N/A	N/A	DWS Contrast?	N/A
N/A	Landing Slope (%)	N/A	N/A	DWS Length (in)	N/A
N/A	Landing X Slope (%)	N/A	N/A	DWS Full Width?	N/A
N/A	Landing Curb? (Y/N)	N/A	N/A	DWS Offset (in)	N/A
N/A	Shared Landing?	N/A			
N/A	Gutter Ponding?	N/A	N/A	Gutter Slope (%)	N/A
N/A	Gutter Lip Ht (in)	N/A	N/A	Gutter X Slope (%)	N/A
N/A	Painted X Walk1?	Yes	N/A	Painted X Walk2?	N/A
	X Walk 1 Direction	To S		X Walk 2 Direction	N/A
N/A	X Walk 1 Width (in)	116.0	N/A	X Walk 2 Width (in)	N/A
	X Walk 1 Slope (%)	0.8		X Walk 2 Slope (%)	N/A
	X Walk 1 X Slope (%)	2.3		X Walk 2 X Slope (%)	N/A

N/A	Ramp inside XWalk1?	Yes	N/A	Ramp inside XWalk2?	N/A
	Road Slope (%)	N/A	N/A	Clear Space?	N/A
	Road X Slope (%)	N/A	N/A	Clear Space to XWalk (in)	N/A
N/A	Any Obstructions?	N/A	N/A	Storm Grate/Utility Hazard?	N/A
	Obstruction Type			Storm Grate/Utility Type	
		N/A			N/A
		Yes		Surface Condition? (G/P)	Good

Remove & Replace Entire Ramp.
