# Access Compliance Report

## Public Rights-of-Way

### (Curb Ramps)

| Intersection ID: N/A | Main Street: TIFFANY_ROSE_PL | Cross Street: W_CRAIGHEAD_RD | Location: NE |

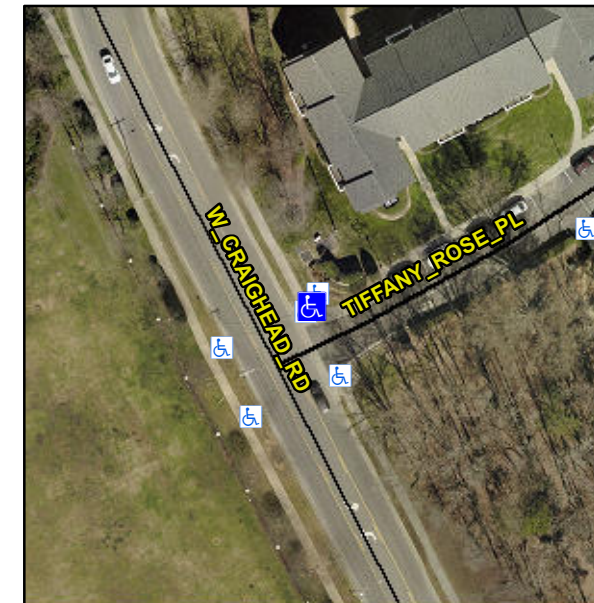
**Not Found, R304.5.1, R304.5.3, R304.3.2**

| Compliance | Description | Data | Compliance | Description | Data |
|---|---|---|---|---|---|
| No | Ramp Slope LT (%) | 12.0 | Yes | Ramp Slope RT (%) | 1.8 |
| Yes | Ramp XSlope LT (%) | 1.6 | No | Ramp XSlope RT (%) | 2.6 |
| No | Ramp Width (in) | 45.0 | No | Ramp XSlope (%) | 3.7 |

**Remove & Replace Curb Ramp With Two New Directional Ramps or Equivalent.**
