Access Compliance Report

Public Rights-of-Way

(Curb Ramps)

| Intersection ID: 10019902 | Main Street: ARCO_CORPORATE_DR | Cross Street: N/A | Location: NW |

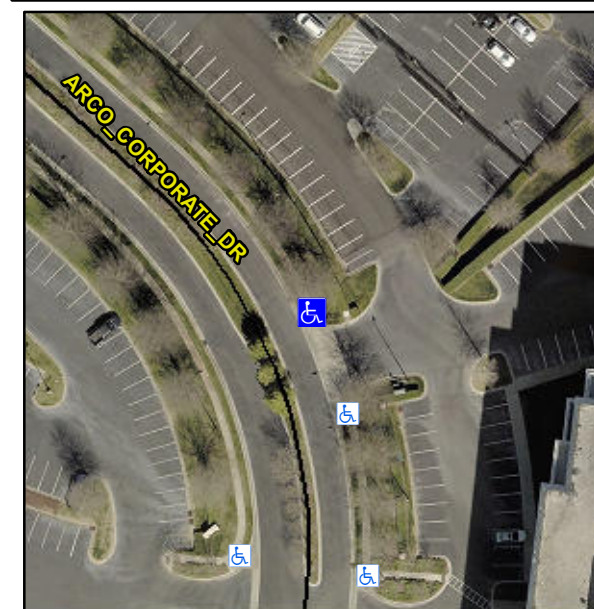
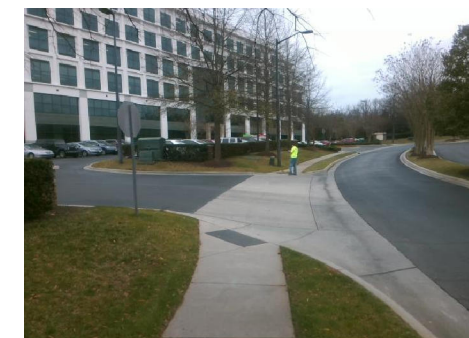
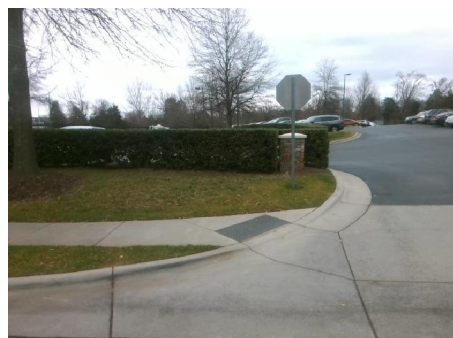
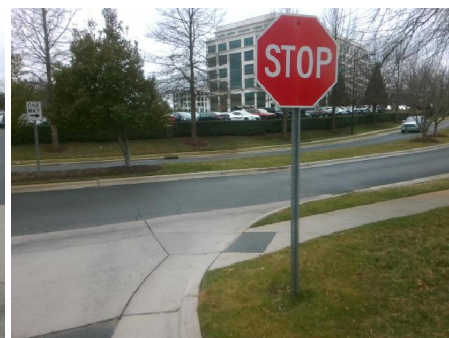
| ADA ID: 1226EC870430 | Ramp Type: Directional1 | Initial Pass/Fail: Fail | Overall Compliance: No |

R304.2.2, R304.5.3

| Compliance | Description | Data | Compliance | Description | Data |
|---|---|---|---|---|---|
| No | Ramp Slope (%) | 8.7 | N/A | Grade Break XSlope (%) | 0.0 |
| No | Ramp XSlope (%) | 5.4 | | | |

Remove & Replace Entire Ramp.

Total Cost: \$ 1600.00
