Access Compliance Report Public Rights-of-Way (Curb Ramps)

Intersection ID: 9995
 Main Street:
 BEATTIES_FORD_RD
 Cross Street:
 FRENCH_ST
 Location:
 NW

ADA ID: 122A1D122219
 Ramp Type:
 PerpDiag
 Initial Pass/Fail:
 Fail
 Overall Compliance:
 No
 Severity Score:
 35

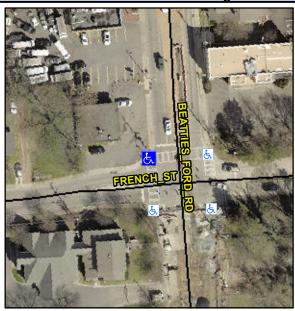
Not Found, R304.5.1, R304.2.2, R304.5.3

Compliance Description		Data	Data Compliance Description		Data
N/A	Ramp Length (in)	47.5	No	Ramp Slope (%)	13.3
No	Ramp Width (in)	44.0	No	Ramp XSlope (%)	3.6
N/A	Flare Type LT	N/A	N/A	Flare Type RT	N/A
N/A	Flare Slope LT (%)	N/A	N/A	Flare Slope RT (%)	N/A
N/A	Flare Traversable LT?	N/A	N/A	Flare Traversable RT?	N/A
N/A	Landing Length (in)	N/A	N/A	DWS Provided?	N/A
N/A	Landing Width (in)	N/A	N/A	DWS Contrast?	N/A
N/A	Landing Slope (%)	N/A	N/A	DWS Length (in)	N/A
N/A	Landing X Slope (%)	N/A	N/A	DWS Full Width?	N/A
N/A	Landing Curb? (Y/N)	N/A	N/A	DWS Offset (in)	N/A
N/A	Shared Landing?	N/A			
N/A	Gutter Ponding?	N/A	N/A	Gutter Slope (%)	N/A
N/A	Gutter Lip Ht (in)	0.5	N/A	Gutter X Slope (%)	N/A
N/A	Painted X Walk1?	Yes	N/A	Painted X Walk2?	Yes
	X Walk 1 Direction	To S		X Walk 2 Direction	То Е
N/A	X Walk 1 Width (in)	104.0	N/A	X Walk 2 Width (in)	107.0
	X Walk 1 Slope (%)	2.3		X Walk 2 Slope (%)	1.2
	X Walk 1 X Slope (%)	2.9		X Walk 2 X Slope (%)	3.8

Remove & Replace Curb Ramp With Two New Directional Ramps or Equivalent.
