# Access Compliance Report

## Public Rights-of-Way

### (Curb Ramps)

Intersection ID: 31891	Main Street: CENTERLINE_DR	Cross Street: MOUNTAIN_SPRINGS_DR	Location: SW
ADA ID: 122D7DBD41FD	Ramp Type: BlendTrans1	Initial Pass/Fail: Fail	Overall Compliance: No
Severity Score: 8.75			
Codes/Mitigation Info/Possible Solution		Field Measurements/Component Compliance

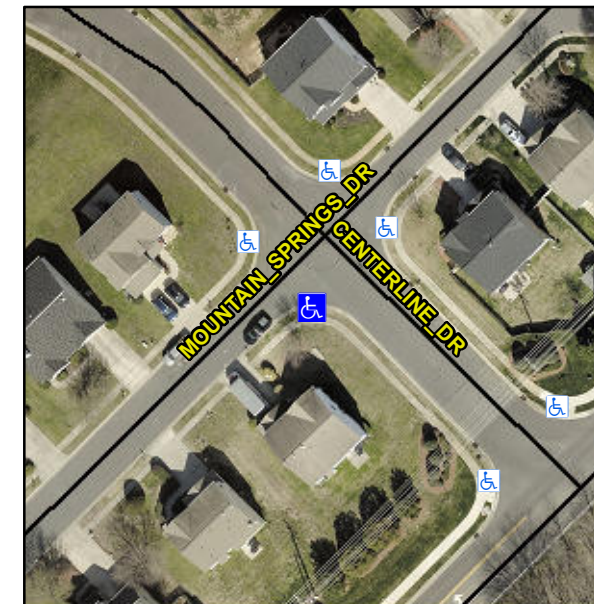
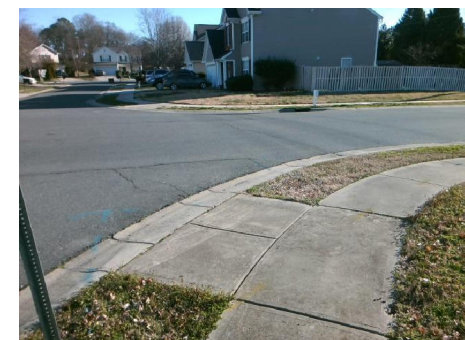
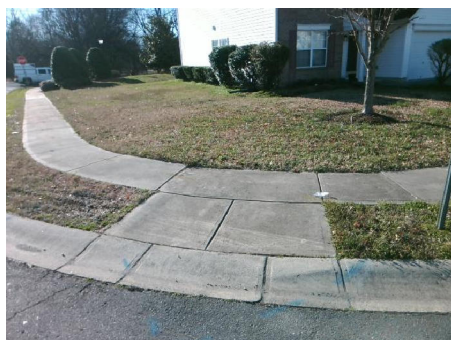
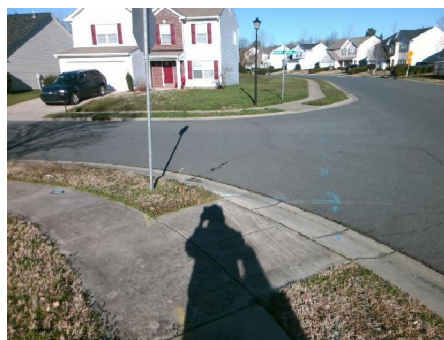
**Not Found, R304.5.1**

Compliance	Description	Data	Compliance	Description	Data
N/A	Ramp Length (in)	47.5	Yes	BlendTrans Slope (%)	4.5
No	Ramp Width (in)	45.3	Yes	BlendTrans XSlope (%)	0.9
N/A	Flare Type LT	N/A	N/A	Flare Type RT	N/A
N/A	Flare Slope LT (%)	N/A	N/A	Flare Slope RT (%)	N/A
N/A	Flare Traversable LT?	N/A	N/A	Flare Traversable RT?	N/A
N/A	Landing Length (in)	N/A	N/A	DWS Provided?	N/A
N/A	Landing Width (in)	N/A	N/A	DWS Contrast?	N/A
N/A	Landing Slope (%)	N/A	N/A	DWS Length (in)	N/A
N/A	Landing X Slope (%)	N/A	N/A	DWS Full Width?	N/A
N/A	Landing Curb? (Y/N)	N/A	N/A	DWS Offset (in)	N/A
N/A	Shared Landing?	N/A			
N/A	Gutter Ponding?	N/A	N/A	Gutter Slope (%)	N/A
N/A	Gutter Lip Ht (in)	N/A	N/A	Gutter X Slope (%)	N/A
N/A	Painted X Walk1?	No	N/A	Painted X Walk2?	No
	X Walk 1 Direction	To NE		X Walk 2 Direction	To NW
	X Walk 1 Width (in)	N/A		X Walk 2 Width (in)	N/A
	X Walk 1 Slope (%)	0.7		X Walk 2 Slope (%)	3.4
	X Walk 1 X Slope (%)	0.9		X Walk 2 X Slope (%)	2.7

N/A	Ramp inside XWalk1?	N/A	N/A	Ramp inside XWalk2?	N/A
	Road Slope (%)	1.1		Clear Space?	N/A
	Road X Slope (%)	1.7	N/A	Clear Space to XWalk (in)	N/A
N/A	Any Obstructions?	N/A	N/A	Storm Grate/Utility Hazard?	N/A
	Obstruction Type			Storm Grate/Utility Type	
		N/A			N/A
			Yes	Surface Condition? (G/P)	Good
			No	Curb Slope (%)	16.4

**Remove & Replace Curb Ramp With Two New Directional Ramps or Equivalent.**
