Access Compliance Report

Public Rights-of-Way

(Curb Ramps)

Intersection ID: 45164	Main Street: ELESSAR_PL	Cross Street: ARAGORN_LN	Location:	S
ADA ID: 122FD70469FC	Ramp Type: PerpDiag	Initial Pass/Fail: Fail	Overall Compliance: No	Severity Score: 37.5
Codes/Mitigation Info/Possible Solution		Field Measurements/Component Compliance

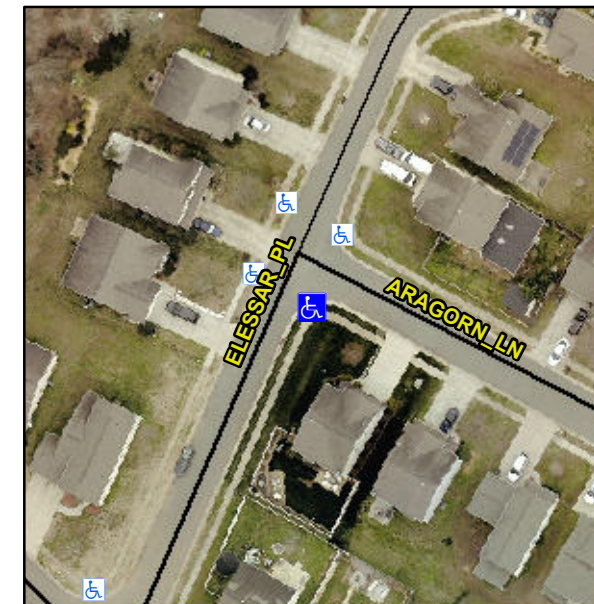
Compliance	Description	Data	Compliance	Description	Data
N/A	Ramp Length (in)	48.0	No	Ramp Slope (%)	10.6
Yes	Ramp Width (in)	48.0	No	Ramp XSlope (%)	7.6
N/A	Flare Type LT	N/A	N/A	Flare Type RT	N/A
N/A	Flare Slope LT (%)	N/A	N/A	Flare Slope RT (%)	N/A
N/A	Flare Traversable LT?	N/A	N/A	Flare Traversable RT?	N/A
N/A	Landing Length (in)	N/A	N/A	DWS Provided?	N/A
N/A	Landing Width (in)	N/A	N/A	DWS Contrast?	N/A
N/A	Landing Slope (%)	N/A	N/A	DWS Length (in)	N/A
N/A	Landing X Slope (%)	N/A	N/A	DWS Full Width?	N/A
N/A	Landing Curb? (Y/N)	N/A	N/A	DWS Offset (in)	N/A
N/A	Shared Landing?	N/A			
N/A	Gutter Ponding?	N/A	N/A	Gutter Slope (%)	N/A
N/A	Gutter Lip Ht (in)	N/A	N/A	Gutter X Slope (%)	N/A
N/A	Painted X Walk1?	No	N/A	Painted X Walk2?	No
	X Walk 1 Direction	To NE		X Walk 2 Direction	To NW
N/A	X Walk 1 Width (in)	N/A	N/A	X Walk 2 Width (in)	N/A
	X Walk 1 Slope (%)	4.4		X Walk 2 Slope (%)	3.9
	X Walk 1 X Slope (%)	4.0		X Walk 2 X Slope (%)	6.3

N/A	Ramp inside XWalk1?	N/A	N/A	Ramp inside XWalk2?	N/A
	Road Slope (%)	7.9	N/A	Clear Space?	N/A
	Road X Slope (%)	1.1	N/A	Clear Space to XWalk (in)	N/A
N/A	Any Obstructions?	N/A	N/A	Storm Grate/Utility Hazard?	N/A
	Obstruction Type			Storm Grate/Utility Type	
		N/A			N/A
			Yes	Surface Condition? (G/P)	Good

Remove & Replace Curb Ramp With Two New Directional Ramps or Equivalent.

R304.2.2, R304.5.3
