Access Compliance Report

Public Rights-of-Way

(Curb Ramps)

Intersection ID: 15340	Main Street: CHARLOTTE_DR	Cross Street: LATTIMORE_ST	Location:	S
ADA ID: 123DEA07CA76	Ramp Type: Perp	Initial Pass/Fail: Fail	Overall Compliance: No	Severity Score: 12.5
Codes/Mitigation Info/Possible Solution		Field Measurements/Component Compliance

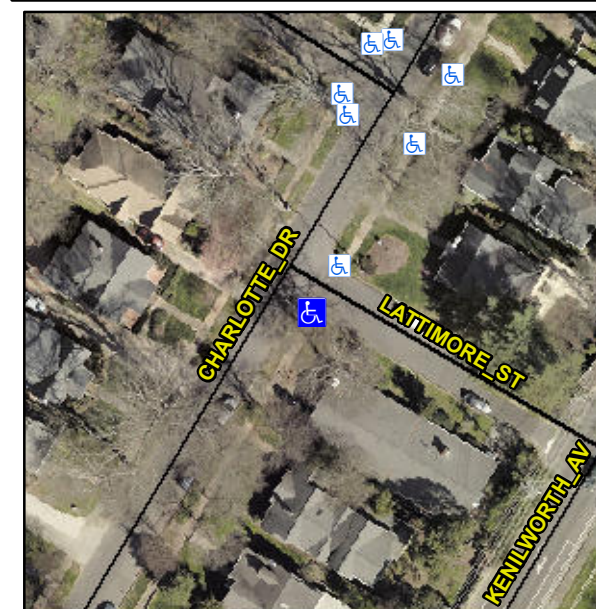
Compliance	Description	Data	Compliance	Description	Data
N/A	Ramp Length (in)	66.0	No	Ramp Slope (%)	9.0
Yes	Ramp Width (in)	48.0	Yes	Ramp XSlope (%)	0.4
N/A	Flare Type LT	N/A	N/A	Flare Type RT	N/A
N/A	Flare Slope LT (%)	N/A	N/A	Flare Slope RT (%)	N/A
N/A	Flare Traversable LT?	N/A	N/A	Flare Traversable RT?	N/A
N/A	Landing Length (in)	N/A	N/A	DWS Provided?	N/A
N/A	Landing Width (in)	N/A	N/A	DWS Contrast?	N/A
N/A	Landing Slope (%)	N/A	N/A	DWS Length (in)	N/A
N/A	Landing X Slope (%)	N/A	N/A	DWS Full Width?	N/A
N/A	Landing Curb? (Y/N)	N/A	N/A	DWS Offset (in)	N/A
N/A	Shared Landing?	N/A			
N/A	Gutter Ponding?	N/A	N/A	Gutter Slope (%)	N/A
N/A	Gutter Lip Ht (in)	1.0	N/A	Gutter X Slope (%)	N/A
N/A	Painted X Walk1?	No	N/A	Painted X Walk2?	N/A
	X Walk 1 Direction	To NE		X Walk 2 Direction	N/A
N/A	X Walk 1 Width (in)	N/A	N/A	X Walk 2 Width (in)	N/A
	X Walk 1 Slope (%)	3.5		X Walk 2 Slope (%)	N/A
	X Walk 1 X Slope (%)	0.3		X Walk 2 X Slope (%)	N/A

N/A	Ramp inside XWalk1?	N/A	N/A	Ramp inside XWalk2?	N/A
	Road Slope (%)	N/A	N/A	Clear Space?	N/A
	Road X Slope (%)	N/A	N/A	Clear Space to XWalk (in)	N/A
N/A	Any Obstructions?	N/A	N/A	Storm Grate/Utility Hazard?	N/A
	Obstruction Type			Storm Grate/Utility Type	
		N/A			N/A
			Yes	Surface Condition? (G/P)	Good

Possible Solutions:

Remove & Replace Entire Ramp.

R304.2.2

Total Cost: \$ 1850.00
