Access Compliance Report

Public Rights-of-Way

(Curb Ramps)

Intersection ID: 49137	Main Street: LESTER_HILL_CT	Cross Street: POPE_FARM_RD	Location: NE
ADA ID: 1240ABB85A7C	Ramp Type: Perp	Initial Pass/Fail: Pass	Overall Compliance: No
Codes/Mitigation Info/Possible Solution		Field Measurements/Component Compliance

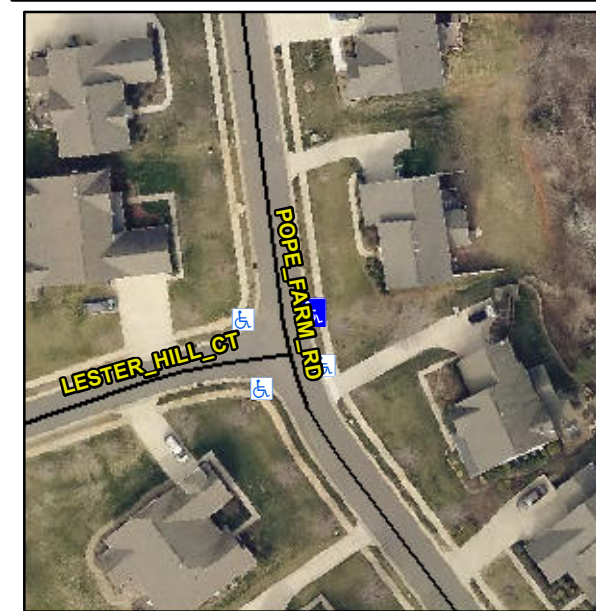
Not Found, R304.2.2-Perp, R304.3.2-Para, R305.2

Compliance	Description	Data	Compliance	Description	Data
N/A	Ramp Length (in)	46.5	Yes	Ramp Slope (%)	6.7
Yes	Ramp Width (in)	48.0	Yes	Ramp XSlope (%)	0.6
N/A	Flare Type LT	Sloped	N/A	Flare Type RT	N/A
N/A	Flare Slope LT (%)	9.6	Yes	Flare Slope RT (%)	7.9
N/A	Flare Traversable LT?	Yes	N/A	Flare Traversable RT?	Yes
Yes	Landing Length (in)	48.0	Yes	DWS Provided?	Yes
Yes	Landing Width (in)	48.0	Yes	DWS Contrast?	Yes
No	Landing Slope (%)	3.1	Yes	DWS Length (in)	24.5
Yes	Landing X Slope (%)	0.5	Yes	DWS Full Width?	Yes
N/A	Landing Curb? (Y/N)	No	No	DWS Offset (in)	8.0
N/A	Shared Landing?	No			
Yes	Gutter Ponding?	No	Yes	Gutter Slope (%)	0.6
Yes	Gutter Lip Ht (in)	0.0	Yes	Gutter X Slope (%)	0.2
N/A	Painted X Walk1?	No	N/A	Painted X Walk2?	N/A
	X Walk 1 Direction	To W		X Walk 2 Direction	N/A
N/A	X Walk 1 Width (in)	N/A	N/A	X Walk 2 Width (in)	N/A
	X Walk 1 Slope (%)	0.5		X Walk 2 Slope (%)	N/A
	X Walk 1 X Slope (%)	5.1		X Walk 2 X Slope (%)	N/A

N/A	Ramp inside XWalk1?	N/A	N/A	Ramp inside XWalk2?	N/A
	Road Slope (%)	N/A	N/A	Clear Space?	Yes
	Road X Slope (%)	N/A	N/A	Clear Space to XWalk (in)	N/A
Yes	Any Obstructions?	No	Yes	Storm Grate/Utility Hazard?	No
	Obstruction Type			Storm Grate/Utility Type	
		N/A			N/A
			Yes	Surface Condition? (G/P)	Good

Remove & Replace Entire Ramp.

Total Cost: \$ 1850.00
