Access Compliance Report

Public Rights-of-Way

(Curb Ramps)

Intersection ID: 53289	Main Street: PROSPERITY RIDGE RD	Cross Street: CRAVEN THOMAS RD	Location: W
ADA ID: 1245A1A65208	Ramp Type: Perp	Initial Pass/Fail: Pass	Overall Compliance: No
Severity Score: 0			
Codes/Mitigation Info/Possible Solution		Field Measurements/Component Compliance

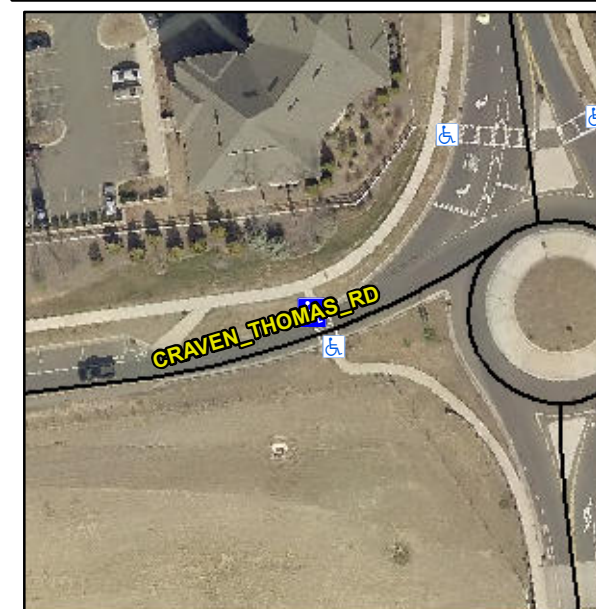
Compliance	Description	Data	Compliance	Description	Data
N/A	Ramp Length (in)	136.0	Yes	Ramp Slope (%)	6.7
Yes	Ramp Width (in)	48.0	Yes	Ramp XSlope (%)	1.9
N/A	Flare Type LT	Sloped	N/A	Flare Type RT	N/A
N/A	Flare Slope LT (%)	9.4	N/A	Flare Slope RT (%)	5.8
N/A	Flare Traversable LT?	No	N/A	Flare Traversable RT?	No
Yes	Landing Length (in)	70.0	Yes	DWS Provided?	Yes
Yes	Landing Width (in)	48.0	Yes	DWS Contrast?	Yes
Yes	Landing Slope (%)	1.8	Yes	DWS Length (in)	24.0
Yes	Landing X Slope (%)	1.9	Yes	DWS Full Width?	Yes
N/A	Landing Curb? (Y/N)	No	No	DWS Offset (in)	5.0
N/A	Shared Landing?	No			
Yes	Gutter Ponding?	No	Yes	Gutter Slope (%)	3.3
Yes	Gutter Lip Ht (in)	0.0	Yes	Gutter X Slope (%)	1.3
N/A	Painted X Walk1?	Yes	N/A	Painted X Walk2?	N/A
	X Walk 1 Direction	To S		X Walk 2 Direction	N/A
N/A	X Walk 1 Width (in)	104.0	N/A	X Walk 2 Width (in)	N/A
	X Walk 1 Slope (%)	2.0		X Walk 2 Slope (%)	N/A
	X Walk 1 X Slope (%)	0.9		X Walk 2 X Slope (%)	N/A

Yes	Ramp inside XWalk1?	Yes	N/A	Ramp inside XWalk2?	N/A
	Road Slope (%)	N/A	N/A	Clear Space?	Yes
	Road X Slope (%)	N/A	N/A	Clear Space to XWalk (in)	N/A
Yes	Any Obstructions?	No	Yes	Storm Grate/Utility Hazard?	No
	Obstruction Type			Storm Grate/Utility Type	
		N/A			N/A
			Yes	Surface Condition? (G/P)	Good

Possible Solutions:

Remove & Replace Detectable Warning System.

R305.2

\$ 800.00
