Access Compliance Report

Public Rights-of-Way

(Curb Ramps)

Intersection ID: 13857	Main Street: ALBEMARLE_RD	Cross Street: DENBUR_DR	Location: W
ADA ID: 1247FA6EA651	Ramp Type: Perp	Initial Pass/Fail: Fail	Overall Compliance: No
Severity Score: 33.75			
Codes/Mitigation Info/Possible Solution		Field Measurements/Component Compliance

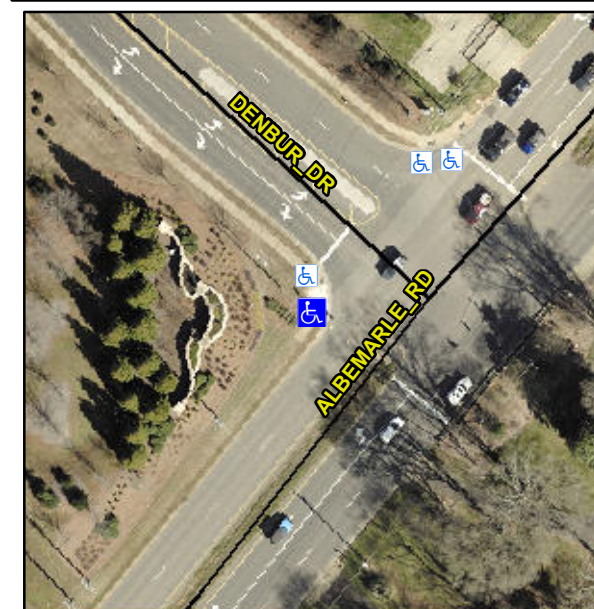
Not Found, R304.5.1, R304.2.2

Compliance	Description	Data	Compliance	Description	Data
N/A	Ramp Length (in)	48.0	No	Ramp Slope (%)	12.2
No	Ramp Width (in)	47.5	Yes	Ramp XSlope (%)	1.9
N/A	Flare Type LT	N/A	N/A	Flare Type RT	N/A
N/A	Flare Slope LT (%)	N/A	N/A	Flare Slope RT (%)	N/A
N/A	Flare Traversable LT?	N/A	N/A	Flare Traversable RT?	N/A
N/A	Landing Length (in)	N/A	N/A	DWS Provided?	N/A
N/A	Landing Width (in)	N/A	N/A	DWS Contrast?	N/A
N/A	Landing Slope (%)	N/A	N/A	DWS Length (in)	N/A
N/A	Landing X Slope (%)	N/A	N/A	DWS Full Width?	N/A
N/A	Landing Curb? (Y/N)	N/A	N/A	DWS Offset (in)	N/A
N/A	Shared Landing?	N/A			
N/A	Gutter Ponding?	N/A	N/A	Gutter Slope (%)	N/A
N/A	Gutter Lip Ht (in)	N/A	N/A	Gutter X Slope (%)	N/A
N/A	Painted X Walk1?	No	N/A	Painted X Walk2?	N/A
	X Walk 1 Direction	To SE		X Walk 2 Direction	N/A
N/A	X Walk 1 Width (in)	N/A	N/A	X Walk 2 Width (in)	N/A
	X Walk 1 Slope (%)	2.4		X Walk 2 Slope (%)	N/A
	X Walk 1 X Slope (%)	0.2		X Walk 2 X Slope (%)	N/A

N/A	Ramp inside XWalk1?	N/A	N/A	Ramp inside XWalk2?	N/A
	Road Slope (%)	0.2	N/A	Clear Space?	N/A
	Road X Slope (%)	2.4	N/A	Clear Space to XWalk (in)	N/A
N/A	Any Obstructions?	N/A	N/A	Storm Grate/Utility Hazard?	N/A
	Obstruction Type			Storm Grate/Utility Type	
		N/A			N/A
			Yes	Surface Condition? (G/P)	Good

Remove & Replace Entire Ramp.
