Access Compliance Report

Public Rights-of-Way

(Curb Ramps)

Intersection ID: 52915	Main Street: WILLOW_GREEN_PL	Cross Street: WOODWARD_AV	Location: NE
ADA ID: 124B4B16A1B5	Ramp Type: Directional1	Initial Pass/Fail: Fail	Overall Compliance: No
Severity Score: 1.25			
Codes/Mitigation Info/Possible Solution		Field Measurements/Component Compliance

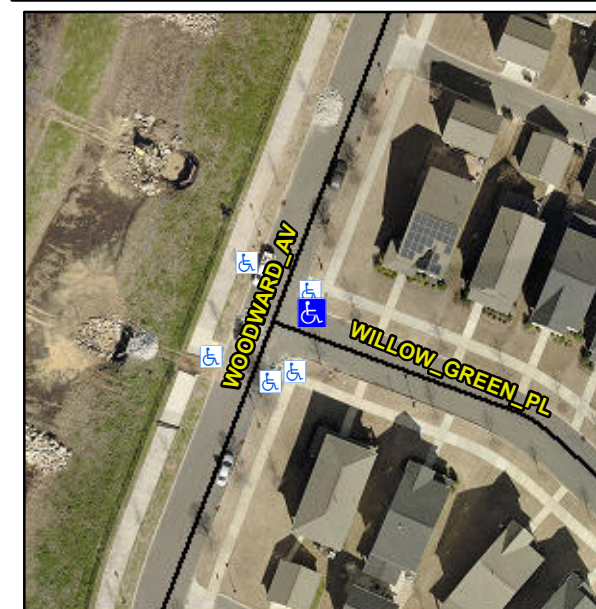
Compliance	Description	Data	Compliance	Description	Data
N/A	Ramp Length (in)	69.0	N/A	Grade Break?	N/A
Yes	Ramp Width (in)	60.0	N/A	Grade Break Slope (%)	0.0
Yes	Ramp Slope (%)	7.4	N/A	Grade Break XSlope (%)	0.0
No	Ramp XSlope (%)	2.4			
N/A	Flare Type LT	N/A	N/A	Flare Type RT	N/A
N/A	Flare Slope LT (%)	N/A	N/A	Flare Slope RT (%)	0.0
N/A	Flare Traversable LT?	N/A	N/A	Flare Traversable RT?	N/A
N/A	Landing Length (in)	0.0	N/A	DWS Provided?	N/A
N/A	Landing Width (in)	0.0	N/A	DWS Contrast?	N/A
N/A	Landing Slope (%)	0.0	N/A	DWS Length (in)	N/A
N/A	Landing X Slope (%)	0.0	N/A	DWS Full Width?	N/A
N/A	Landing Curb? (Y/N)	N/A	N/A	DWS Offset LT (in)	N/A
N/A	Shared Landing?	N/A	N/A	DWS Offset RT (in)	N/A
N/A	Gutter Ponding?	0.0	N/A	Gutter Slope (%)	N/A
N/A	Gutter Lip Ht (in)	0.0	N/A	Gutter X Slope (%)	N/A
N/A	Painted X Walk1?	No		Road Slope (%)	3.0
	X Walk 1 Direction	To S		Road X Slope (%)	1.7
	X Walk 1 Width (in)	N/A		Clear Space?	N/A

X Walk 1 Slope (%)	3.0	N/A	Clear Space to XWalk (in)	N/A
	X Walk 1 X Slope (%)	1.7	N/A	Storm Grate/Utility Hazard?	N/A
N/A	Ramp inside XWalk1?	N/A		Storm Grate/Utility Type	
N/A	Any Obstructions?	N/A			N/A
	Obstruction Type		Yes	Surface Condition? (G/P)	Good
			N/A	Curb Slope (%)	6.1

Possible Solutions:

Remove & Replace Entire Ramp.

R304.5.3

\$ 1600.00
