Access Compliance Report

Public Rights-of-Way

(Curb Ramps)

Intersection ID: N/A	Main Street: N/A	Cross Street: W T HARRIS BV	Location: SE
ADA ID: 124FC001392C	Ramp Type: PerpDiag	Initial Pass/Fail: Fail	Overall Compliance: No
		Severity Score: 12.5

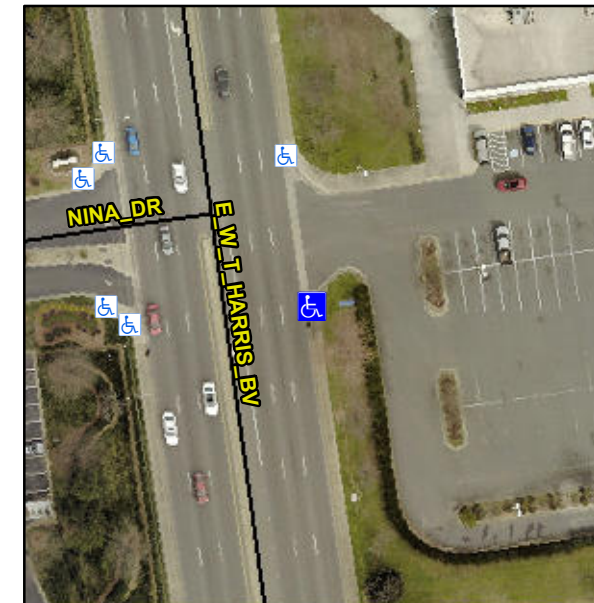
Compliance	Description	Data	Compliance	Description	Data
N/A	Ramp Length (in)	53.0	No	Ramp Slope (%)	9.0
Yes	Ramp Width (in)	48.0	Yes	Ramp XSlope (%)	1.6
N/A	Flare Type LT	N/A	N/A	Flare Type RT	N/A
N/A	Flare Slope LT (%)	N/A	N/A	Flare Slope RT (%)	N/A
N/A	Flare Traversable LT?	N/A	N/A	Flare Traversable RT?	N/A
N/A	Landing Length (in)	N/A	N/A	DWS Provided?	N/A
N/A	Landing Width (in)	N/A	N/A	DWS Contrast?	N/A
N/A	Landing Slope (%)	N/A	N/A	DWS Length (in)	N/A
N/A	Landing X Slope (%)	N/A	N/A	DWS Full Width?	N/A
N/A	Landing Curb? (Y/N)	N/A	N/A	DWS Offset (in)	N/A
N/A	Shared Landing?	N/A			
N/A	Gutter Ponding?	N/A	N/A	Gutter Slope (%)	N/A
N/A	Gutter Lip Ht (in)	N/A	N/A	Gutter X Slope (%)	N/A
N/A	Painted X Walk1?	No	N/A	Painted X Walk2?	No
	X Walk 1 Direction	To N		X Walk 2 Direction	To W
N/A	X Walk 1 Width (in)	N/A	N/A	X Walk 2 Width (in)	N/A
	X Walk 1 Slope (%)	3.9		X Walk 2 Slope (%)	1.8
	X Walk 1 X Slope (%)	0.9		X Walk 2 X Slope (%)	0.7

N/A	Ramp inside XWalk1?	N/A	N/A	Ramp inside XWalk2?	N/A
	Road Slope (%)	1.4	N/A	Clear Space?	N/A
	Road X Slope (%)	1.0	N/A	Clear Space to XWalk (in)	N/A
N/A	Any Obstructions?	N/A	N/A	Storm Grate/Utility Hazard?	N/A
	Obstruction Type			Storm Grate/Utility Type	
		N/A			N/A
			Yes	Surface Condition? (G/P)	Good

Possible Solutions:

Remove & Replace Curb Ramp With Two New Directional Ramps or Equivalent.
