# Access Compliance Report

## Public Rights-of-Way

### (Curb Ramps)

Intersection ID: 10025368	Main Street: E_8TH_ST	Cross Street: N BREVARD ST	Location: W
ADA ID: 12575D55C121	Ramp Type: BlendTrans1	Initial Pass/Fail: Pass	Overall Compliance: No
Severity Score: 15			
Codes/Mitigation Info/Possible Solution		Field Measurements/Component Compliance

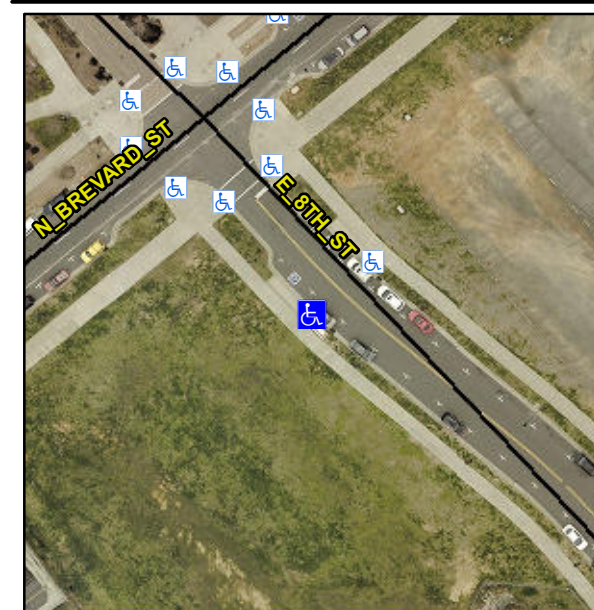
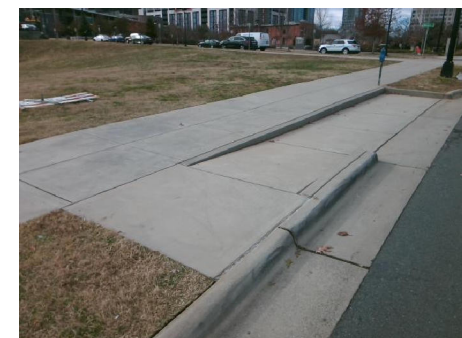
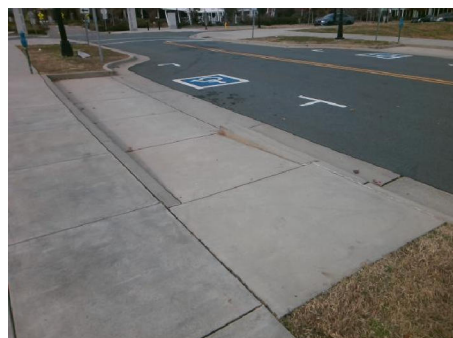
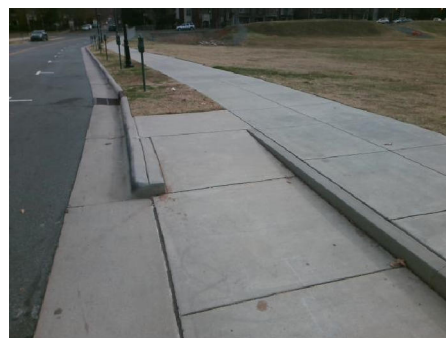
**ACCESS AISLE RAMP**

**R304.2.2-Perp, R304.3.2-Para, R304.5.3, R304.2.3, R305, R304.5.4**

Compliance	Description	Data	Compliance	Description	Data
N/A	Ramp Length (in)	73.0	Yes	BlendTrans Slope (%)	1.7
Yes	Ramp Width (in)	60.0	Yes	BlendTrans XSlope (%)	1.3
Yes	Flare Type	Curbed_NoWalkSurface	No	Flare Type	Curbed_WithWalkSurface
N/A	Flare Slope LT (%)	N/A	N/A	Flare Slope RT (%)	N/A
N/A	Flare Traversable LT?	No	N/A	Flare Traversable RT?	No
Yes	Landing Length (in)	59.0	No	DWS Provided?	No
Yes	Landing Width (in)	71.0	N/A	DWS Contrast?	No
No	Landing Slope (%)	3.7	N/A	DWS Length (in)	N/A
No	Landing X Slope (%)	2.1	N/A	DWS Full Width?	No
N/A	Landing Curb? (Y/N)	No	N/A	DWS Offset (in)	N/A
N/A	Shared Landing?	No			
Yes	Gutter Ponding?	No	No	Gutter Slope (%)	N/A
Yes	Gutter Lip Ht (in)	0.0	No	Gutter X Slope (%)	N/A
N/A	Painted X Walk1?	No	N/A	Painted X Walk2?	N/A
	X Walk 1 Direction	To NE		X Walk 2 Direction	N/A
	X Walk 1 Width (in)	N/A		X Walk 2 Width (in)	N/A
	X Walk 1 Slope (%)	2.7		X Walk 2 Slope (%)	N/A

X Walk 1 X Slope (%)	1.0		X Walk 2 X Slope (%)	N/A
N/A	Ramp inside XWalk1?	N/A	N/A	Ramp inside XWalk2?	N/A
	Road Slope (%)	1.0		Clear Space?	Yes
	Road X Slope (%)	2.7	N/A	Clear Space to XWalk (in)	N/A
Yes	Any Obstructions?	No	Yes	Storm Grate/Utility Hazard?	No
	Obstruction Type			Storm Grate/Utility Type	
		N/A			N/A
			Yes	Surface Condition? (G/P)	Good
			Yes	Curb Slope (%)	0.8

**Remove & Replace Curb Ramp With Two New Directional Ramps or Equivalent. Remove & Replace Gutter.**
