Access Compliance Report

Public Rights-of-Way

(Curb Ramps)

Intersection ID: 11538	Main Street: FREEDOM_DR	Cross Street: BERRYHILL_RD	Location: E
ADA ID: 125959C1F10B	Ramp Type: Perp	Initial Pass/Fail: Fail	Overall Compliance: No
Severity Score: 22.5			
Codes/Mitigation Info/Possible Solution		Field Measurements/Component Compliance

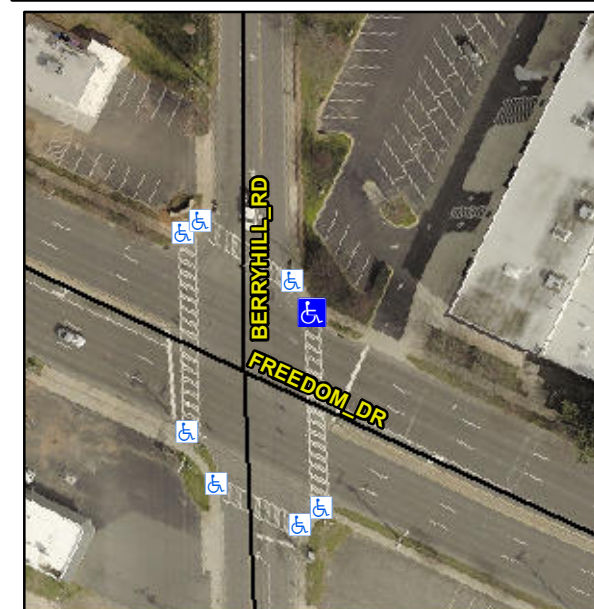
R304.5.1, R304.2.2

Compliance	Description	Data	Compliance	Description	Data
N/A	Ramp Length (in)	76.5	No	Ramp Slope (%)	8.4
No	Ramp Width (in)	47.0	Yes	Ramp XSlope (%)	4.2
N/A	Flare Type LT	N/A	N/A	Flare Type RT	N/A
N/A	Flare Slope LT (%)	N/A	N/A	Flare Slope RT (%)	N/A
N/A	Flare Traversable LT?	N/A	N/A	Flare Traversable RT?	N/A
N/A	Landing Length (in)	N/A	N/A	DWS Provided?	N/A
N/A	Landing Width (in)	N/A	N/A	DWS Contrast?	N/A
N/A	Landing Slope (%)	N/A	N/A	DWS Length (in)	N/A
N/A	Landing X Slope (%)	N/A	N/A	DWS Full Width?	N/A
N/A	Landing Curb? (Y/N)	N/A	N/A	DWS Offset (in)	N/A
N/A	Shared Landing?	N/A			
N/A	Gutter Ponding?	N/A	N/A	Gutter Slope (%)	N/A
N/A	Gutter Lip Ht (in)	N/A	N/A	Gutter X Slope (%)	N/A
N/A	Painted X Walk1?	Yes	N/A	Painted X Walk2?	N/A
	X Walk 1 Direction	To S		X Walk 2 Direction	N/A
N/A	X Walk 1 Width (in)	105.0	N/A	X Walk 2 Width (in)	N/A
	X Walk 1 Slope (%)	2.5		X Walk 2 Slope (%)	N/A
	X Walk 1 X Slope (%)	5.0		X Walk 2 X Slope (%)	N/A

N/A	Ramp inside XWalk1?	Yes	N/A	Ramp inside XWalk2?	N/A
	Road Slope (%)	N/A	N/A	Clear Space?	N/A
	Road X Slope (%)	N/A	N/A	Clear Space to XWalk (in)	N/A
N/A	Any Obstructions?	N/A	N/A	Storm Grate/Utility Hazard?	N/A
	Obstruction Type			Storm Grate/Utility Type	
		N/A			N/A
		Yes		Surface Condition? (G/P)	Good

Possible Solutions:

Remove & Replace Entire Ramp.

Total Cost: \$ 1850.00
