Access Compliance Report

Public Rights-of-Way

(Curb Ramps)

Intersection ID: 9489	Main Street: STATESVILLE_AV	Cross Street: KOHLER_AV	Location: NE
ADA ID: 12681D1032AE	Ramp Type: Perp	Initial Pass/Fail: Fail	Overall Compliance: No
		Severity Score: 8.75

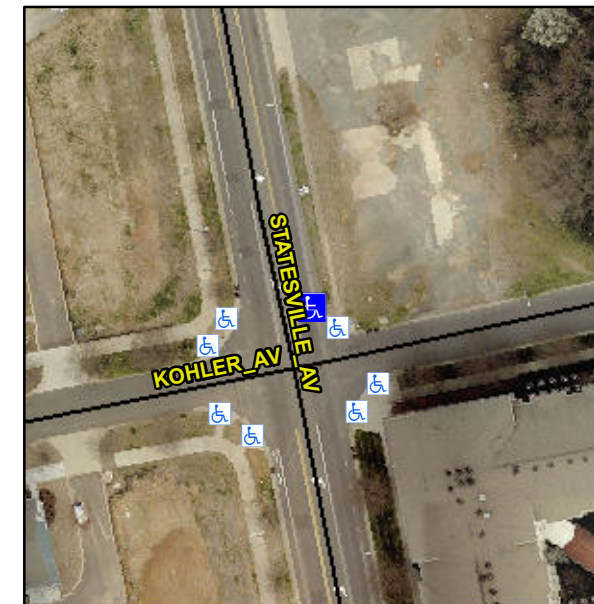
Not Found, R304.5.1

Compliance	Description	Data	Compliance	Description	Data
N/A	Ramp Length (in)	54.5	Yes	Ramp Slope (%)	6.9
No	Ramp Width (in)	46.0	Yes	Ramp XSlope (%)	0.8
N/A	Flare Type LT	N/A	N/A	Flare Type RT	N/A
N/A	Flare Slope LT (%)	N/A	N/A	Flare Slope RT (%)	N/A
N/A	Flare Traversable LT?	N/A	N/A	Flare Traversable RT?	N/A
N/A	Landing Length (in)	N/A	N/A	DWS Provided?	N/A
N/A	Landing Width (in)	N/A	N/A	DWS Contrast?	N/A
N/A	Landing Slope (%)	N/A	N/A	DWS Length (in)	N/A
N/A	Landing X Slope (%)	N/A	N/A	DWS Full Width?	N/A
N/A	Landing Curb? (Y/N)	N/A	N/A	DWS Offset (in)	N/A
N/A	Shared Landing?	N/A			
N/A	Gutter Ponding?	N/A	N/A	Gutter Slope (%)	N/A
N/A	Gutter Lip Ht (in)	N/A	N/A	Gutter X Slope (%)	N/A
N/A	Painted X Walk1?	No	N/A	Painted X Walk2?	N/A
	X Walk 1 Direction	To W		X Walk 2 Direction	N/A
N/A	X Walk 1 Width (in)	N/A	N/A	X Walk 2 Width (in)	N/A
	X Walk 1 Slope (%)	3.9		X Walk 2 Slope (%)	N/A
	X Walk 1 X Slope (%)	2.0		X Walk 2 X Slope (%)	N/A

N/A	Ramp inside XWalk1?	N/A	N/A	Ramp inside XWalk2?	N/A
	Road Slope (%)	N/A	N/A	Clear Space?	N/A
	Road X Slope (%)	N/A	N/A	Clear Space to XWalk (in)	N/A
N/A	Any Obstructions?	N/A	N/A	Storm Grate/Utility Hazard?	N/A
	Obstruction Type			Storm Grate/Utility Type	
		N/A			N/A
			Yes	Surface Condition? (G/P)	Good

Remove & Replace Entire Ramp.

Total Cost: \$ 1850.00
