Access Compliance Report

Public Rights-of-Way

(Curb Ramps)

Intersection ID: 50597	Main Street: DOWNY_BIRCH_RD	Cross Street: GRAY_WILLOW_RD	Location: NE
ADA ID: 1276F9A40BF5	Ramp Type: Perp	Initial Pass/Fail: Fail	Overall Compliance: No
Severity Score: 1.25			
Codes/Mitigation Info/Possible Solution		Field Measurements/Component Compliance

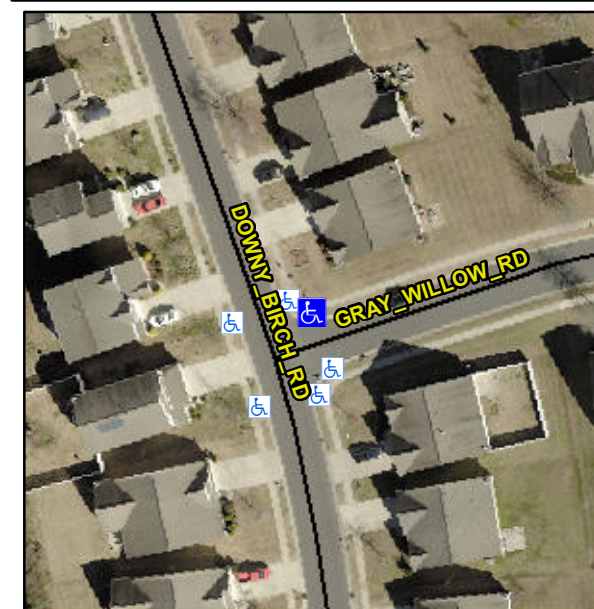
Not Found, R304.5.3

Compliance	Description	Data	Compliance	Description	Data
N/A	Ramp Length (in)	45.5	Yes	Ramp Slope (%)	6.9
Yes	Ramp Width (in)	48.0	No	Ramp XSlope (%)	2.4
N/A	Flare Type LT	N/A	N/A	Flare Type RT	N/A
N/A	Flare Slope LT (%)	N/A	N/A	Flare Slope RT (%)	N/A
N/A	Flare Traversable LT?	N/A	N/A	Flare Traversable RT?	N/A
N/A	Landing Length (in)	N/A	N/A	DWS Provided?	N/A
N/A	Landing Width (in)	N/A	N/A	DWS Contrast?	N/A
N/A	Landing Slope (%)	N/A	N/A	DWS Length (in)	N/A
N/A	Landing X Slope (%)	N/A	N/A	DWS Full Width?	N/A
N/A	Landing Curb? (Y/N)	N/A	N/A	DWS Offset (in)	N/A
N/A	Shared Landing?	N/A			
N/A	Gutter Ponding?	N/A	N/A	Gutter Slope (%)	N/A
N/A	Gutter Lip Ht (in)	N/A	N/A	Gutter X Slope (%)	N/A
N/A	Painted X Walk1?	No	N/A	Painted X Walk2?	N/A
	X Walk 1 Direction	To S		X Walk 2 Direction	N/A
N/A	X Walk 1 Width (in)	N/A	N/A	X Walk 2 Width (in)	N/A
	X Walk 1 Slope (%)	0.9		X Walk 2 Slope (%)	N/A
	X Walk 1 X Slope (%)	2.9		X Walk 2 X Slope (%)	N/A

Remove & Replace Entire Ramp.

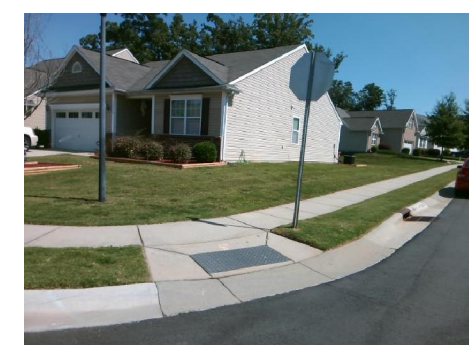
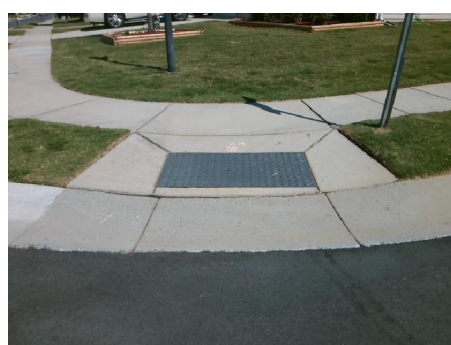
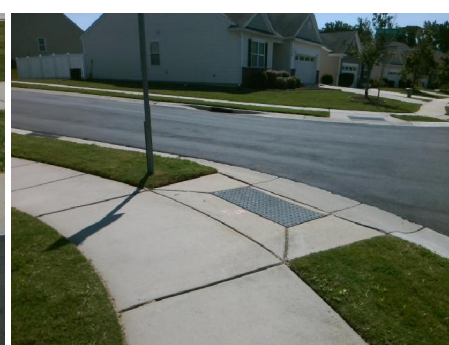
N/A	Ramp inside XWalk1?	N/A	N/A	Ramp inside XWalk2?	N/A
	Road Slope (%)	N/A	N/A	Clear Space?	N/A
	Road X Slope (%)	N/A	N/A	Clear Space to XWalk (in)	N/A
N/A	Any Obstructions?	N/A	N/A	Storm Grate/Utility Hazard?	N/A
	Obstruction Type			Storm Grate/Utility Type	
		N/A			N/A
			Yes	Surface Condition? (G/P)	Good
