Access Compliance Report

Public Rights-of-Way

(Curb Ramps)

Intersection ID: 13784	Main Street: MORNINGSIDE_DR	Cross Street: IVEY_DR	Location: SW
ADA ID: 127AF45DD214	Ramp Type: PerpDiag	Initial Pass/Fail: Fail	Overall Compliance: No
Codes/Mitigation Info/Possible Solution		Field Measurements/Component Compliance

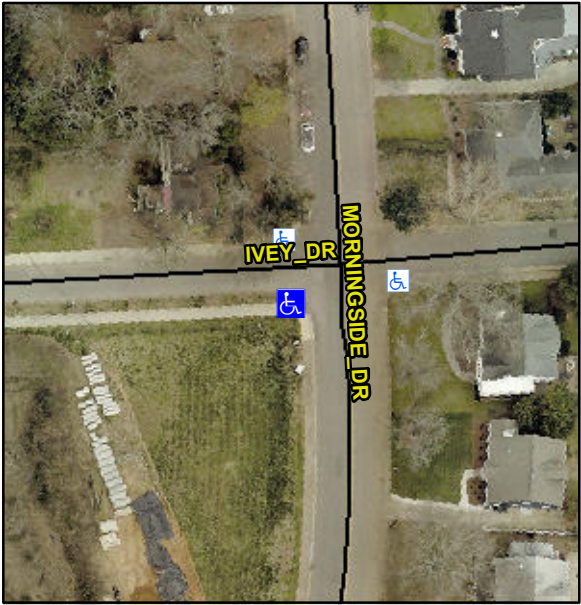
Possible Solutions:	Compliance	Description	Data	Compliance	Description	Data
	Remove & Replace Curb Ramp With Two New Directional Ramps or Equivalent.	N/A	Ramp Length (in)	47.5	No	Ramp Slope (%)	9.2
		Yes	Ramp Width (in)	48.0	No	Ramp XSlope (%)	2.7
		N/A	Flare Type LT	N/A	N/A	Flare Type RT	N/A
		N/A	Flare Slope LT (%)	N/A	N/A	Flare Slope RT (%)	N/A
		N/A	Flare Traversable LT?	N/A	N/A	Flare Traversable RT?	N/A
		N/A	Landing Length (in)	N/A	N/A	DWS Provided?	N/A
		N/A	Landing Width (in)	N/A	N/A	DWS Contrast?	N/A
		N/A	Landing Slope (%)	N/A	N/A	DWS Length (in)	N/A
		N/A	Landing X Slope (%)	N/A	N/A	DWS Full Width?	N/A
		N/A	Landing Curb? (Y/N)	N/A	N/A	DWS Offset (in)	N/A
		N/A	Shared Landing?	N/A			
		N/A	Gutter Ponding?	N/A	N/A	Gutter Slope (%)	N/A
		N/A	Gutter Lip Ht (in)	N/A	N/A	Gutter X Slope (%)	N/A
		N/A	Painted X Walk1?	No	N/A	Painted X Walk2?	No
			X Walk 1 Direction	To E		X Walk 2 Direction	To N

N/A	X Walk 1 Width (in)	N/A	N/A	X Walk 2 Width (in)	N/A
			X Walk 1 Slope (%)	3.5		X Walk 2 Slope (%)	3.7
			X Walk 1 X Slope (%)	1.1		X Walk 2 X Slope (%)	0.6
		N/A	Ramp inside XWalk1?	N/A	N/A	Ramp inside XWalk2?	N/A
<p>Surveyor Notes:</p> <p>N/A</p> <p>PROW/ADA:</p> <p>R304.2.2, R304.5.3</p>			Road Slope (%)	4.4	N/A	Clear Space?	N/A
			Road X Slope (%)	0.2	N/A	Clear Space to XWalk (in)	N/A
Total Cost:		N/A	Any Obstructions?	N/A	N/A	Storm Grate/Utility Hazard?	N/A
			Obstruction Type			Storm Grate/Utility Type	
				N/A			N/A
					Yes	Surface Condition? (G/P)	Good
