# Access Compliance Report

## Public Rights-of-Way

### (Curb Ramps)

Intersection ID: 10026307	Main Street: FAIRVIEW_RD	Cross Street: LIBERTY_ROW	Location: SE
ADA ID: 127D4B9D4F8C	Ramp Type: Directional1	Initial Pass/Fail: Fail	Overall Compliance: No
Severity Score: 37.5			
Codes/Mitigation Info/Possible Solution		Field Measurements/Component Compliance

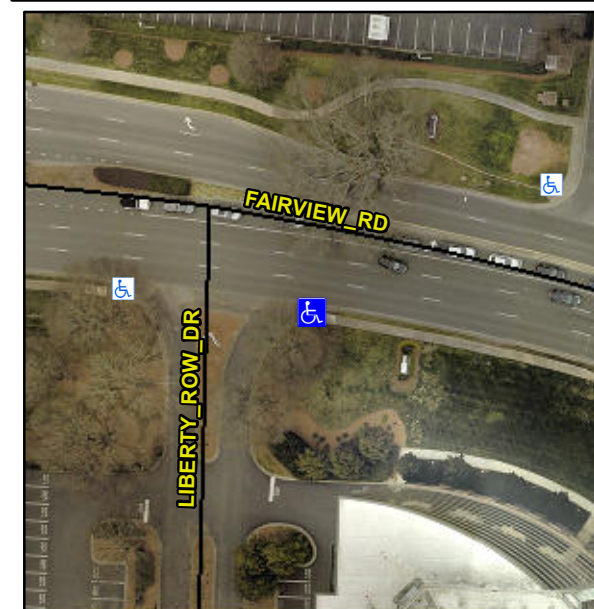
**R304.2.2, R304.5.3**

Compliance	Description	Data	Compliance	Description	Data
N/A	Ramp Length (in)	56.0	N/A	Grade Break?	N/A
Yes	Ramp Width (in)	60.0	N/A	Grade Break Slope (%)	0.0
No	Ramp Slope (%)	9.6	N/A	Grade Break XSlope (%)	0.0
No	Ramp XSlope (%)	12.2			
N/A	Flare Type LT	N/A	N/A	Flare Type RT	N/A
N/A	Flare Slope LT (%)	N/A	N/A	Flare Slope RT (%)	0.0
N/A	Flare Traversable LT?	N/A	N/A	Flare Traversable RT?	N/A
N/A	Landing Length (in)	0.0	N/A	DWS Provided?	N/A
N/A	Landing Width (in)	0.0	N/A	DWS Contrast?	N/A
N/A	Landing Slope (%)	0.0	N/A	DWS Length (in)	N/A
N/A	Landing X Slope (%)	0.0	N/A	DWS Full Width?	N/A
N/A	Landing Curb? (Y/N)	N/A	N/A	DWS Offset LT (in)	N/A
N/A	Shared Landing?	N/A	N/A	DWS Offset RT (in)	N/A
N/A	Gutter Ponding?	0.0	N/A	Gutter Slope (%)	N/A
N/A	Gutter Lip Ht (in)	0.0	N/A	Gutter X Slope (%)	N/A
N/A	Painted X Walk1?	No		Road Slope (%)	1.0
	X Walk 1 Direction	To W		Road X Slope (%)	2.5
	X Walk 1 Width (in)	N/A		Clear Space?	N/A

X Walk 1 Slope (%)	1.0	N/A	Clear Space to XWalk (in)	N/A
	X Walk 1 X Slope (%)	2.5	N/A	Storm Grate/Utility Hazard?	N/A
N/A	Ramp inside XWalk1?	N/A		Storm Grate/Utility Type	
N/A	Any Obstructions?	N/A			N/A
	Obstruction Type		Yes	Surface Condition? (G/P)	Good
			N/A	Curb Slope (%)	7.6

Possible Solutions:

**Remove & Replace Entire Ramp.**
