# Access Compliance Report

## Public Rights-of-Way

### (Curb Ramps)

| Intersection ID: 12517 | Main Street: N_SHARON_AMITY_RD | Cross Street: SHAMROCK_DR | Location: SW |

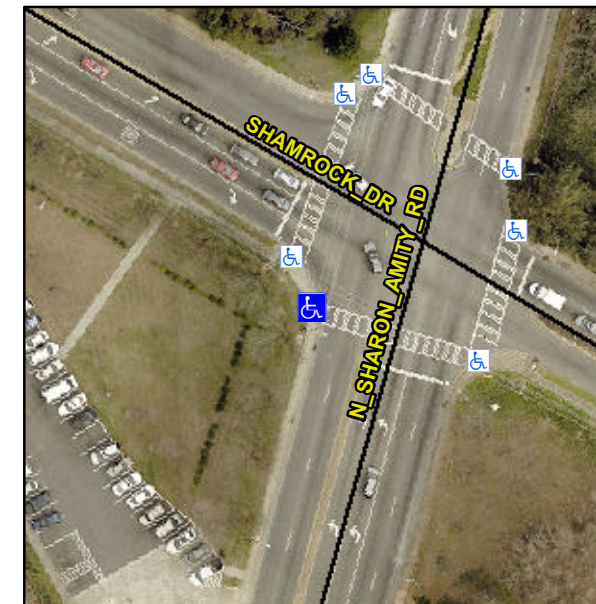
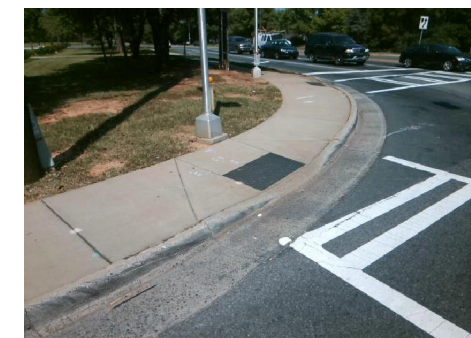
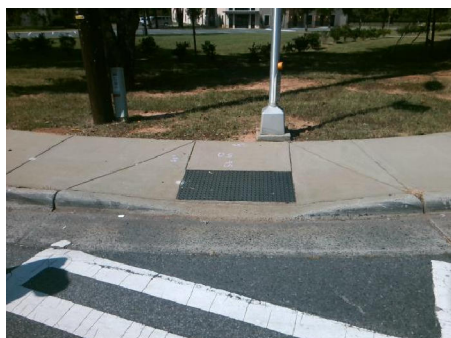
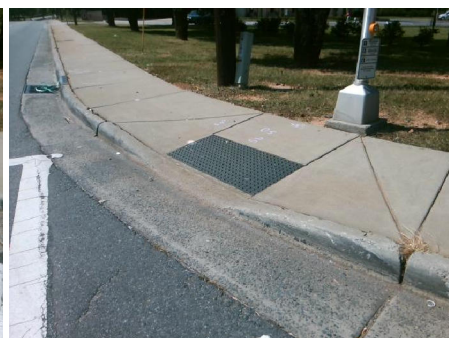
| ADA ID: 128ADA342F1F | Ramp Type: Perp | Initial Pass/Fail: Fail | Overall Compliance: No |

**Not Found, R304.2.2**

| Compliance | Description | Data | Compliance | Description | Data |
|---|---|---|---|---|---|
| N/A | Ramp Length (in) | 59.0 | No | Ramp Slope (%) | 9.5 |

**Remove & Replace Entire Ramp.**

Total Cost: \$ 1850.00
