Access Compliance Report

Public Rights-of-Way

(Curb Ramps)

Intersection ID: 53487	Main Street: SOUTHMORE_DR	Cross Street: MATTHEWS_FARM_LN	Location: SE
ADA ID: 128E8F21840D	Ramp Type: Directional1	Initial Pass/Fail: Fail	Overall Compliance: No
		Severity Score: 1.25

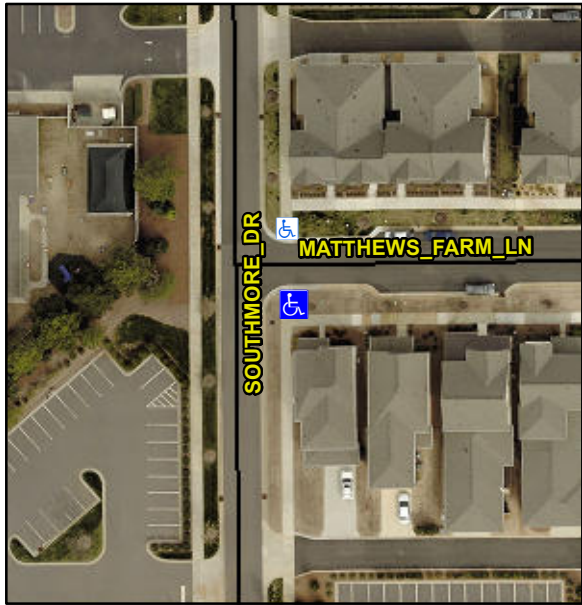
Possible Solutions:		Compliance	Description	Data	Compliance	Description	Data
	Remove & Replace Entire Ramp.		N/A	Ramp Length (in)	156.0	N/A	Grade Break?	N/A
			Yes	Ramp Width (in)	71.0	N/A	Grade Break Slope (%)	0.0
			Yes	Ramp Slope (%)	7.4	N/A	Grade Break XSlope (%)	0.0
			No	Ramp XSlope (%)	2.4			
			N/A	Flare Type LT	N/A	N/A	Flare Type RT	N/A
			N/A	Flare Slope LT (%)	N/A	N/A	Flare Slope RT (%)	0.0
			N/A	Flare Traversable LT?	N/A	N/A	Flare Traversable RT?	N/A
			N/A	Landing Length (in)	0.0	N/A	DWS Provided?	N/A
			N/A	Landing Width (in)	0.0	N/A	DWS Contrast?	N/A
Surveyor Notes:		N/A	N/A	Landing Slope (%)	0.0	N/A	DWS Length (in)	N/A
PROW/ADA:		R304.5.3	N/A	Landing X Slope (%)	0.0	N/A	DWS Full Width?	N/A
			N/A	Landing Curb? (Y/N)	N/A	N/A	DWS Offset LT (in)	N/A
			N/A	Shared Landing?	N/A	N/A	DWS Offset RT (in)	N/A

N/A	Gutter Ponding?	0.0	N/A	Gutter Slope (%)	N/A
			N/A	Gutter Lip Ht (in)	0.0	N/A	Gutter X Slope (%)	N/A
			N/A	Painted X Walk1?	No		Road Slope (%)	0.2
				X Walk 1 Direction	To N		Road X Slope (%)	3.2
				X Walk 1 Width (in)	N/A		Clear Space?	N/A
				X Walk 1 Slope (%)	0.2	N/A	Clear Space to XWalk (in)	N/A
				X Walk 1 X Slope (%)	3.2	N/A	Storm Grate/Utility Hazard?	N/A
			N/A	Ramp inside XWalk1?	N/A		Storm Grate/Utility Type	
			N/A	Any Obstructions?	N/A			N/A
				Obstruction Type		Yes	Surface Condition? (G/P)	Good
					N/A	N/A	Curb Slope (%)	6.1
Street 1 Name		MATTHEWS FARM LN						
Stop Condition-Street 1		StopSign						
Street 2 Name		N/A						
Stop Condition-Street 2		N/A						
Total Cost:		\$ 1600.00
