Access Compliance Report

Public Rights-of-Way

(Curb Ramps)

Intersection ID: 13137	Main Street: CENTRAL_AV	Cross Street: THOMAS_AV	Location: NE
ADA ID: 128F6DA88F9C	Ramp Type: Perp	Initial Pass/Fail: Fail	Overall Compliance: No
Severity Score: 21.25			
Codes/Mitigation Info/Possible Solution		Field Measurements/Component Compliance

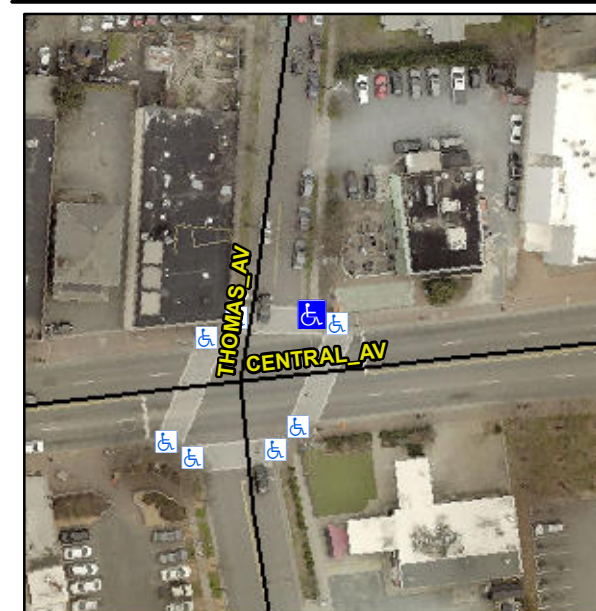
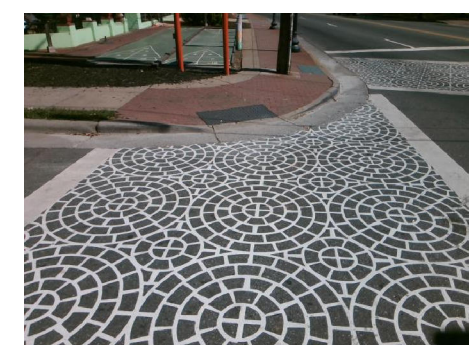
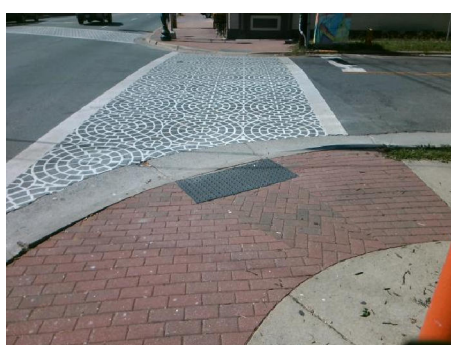
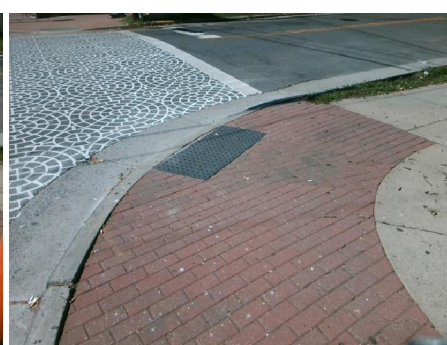
Compliance	Description	Data	Compliance	Description	Data
N/A	Ramp Length (in)	77.0	No	Ramp Slope (%)	9.2
No	Ramp Width (in)	45.0	Yes	Ramp XSlope (%)	0.2
N/A	Flare Type LT	N/A	N/A	Flare Type RT	N/A
N/A	Flare Slope LT (%)	N/A	N/A	Flare Slope RT (%)	N/A
N/A	Flare Traversable LT?	N/A	N/A	Flare Traversable RT?	N/A
N/A	Landing Length (in)	N/A	N/A	DWS Provided?	N/A
N/A	Landing Width (in)	N/A	N/A	DWS Contrast?	N/A
N/A	Landing Slope (%)	N/A	N/A	DWS Length (in)	N/A
N/A	Landing X Slope (%)	N/A	N/A	DWS Full Width?	N/A
N/A	Landing Curb? (Y/N)	N/A	N/A	DWS Offset (in)	N/A
N/A	Shared Landing?	N/A			
N/A	Gutter Ponding?	N/A	N/A	Gutter Slope (%)	N/A
N/A	Gutter Lip Ht (in)	N/A	N/A	Gutter X Slope (%)	N/A
N/A	Painted X Walk1?	Yes	N/A	Painted X Walk2?	N/A
	X Walk 1 Direction	To NW		X Walk 2 Direction	N/A
N/A	X Walk 1 Width (in)	142.5	N/A	X Walk 2 Width (in)	N/A
	X Walk 1 Slope (%)	2.6		X Walk 2 Slope (%)	N/A
	X Walk 1 X Slope (%)	0.5		X Walk 2 X Slope (%)	N/A

N/A	Ramp inside XWalk1?	Yes	N/A	Ramp inside XWalk2?	N/A
	Road Slope (%)	N/A	N/A	Clear Space?	N/A
	Road X Slope (%)	N/A	N/A	Clear Space to XWalk (in)	N/A
N/A	Any Obstructions?	N/A	N/A	Storm Grate/Utility Hazard?	N/A
	Obstruction Type			Storm Grate/Utility Type	
		N/A			N/A
		Yes		Surface Condition? (G/P)	Good

Possible Solutions:

Remove & Replace Entire Ramp.
