# Access Compliance Report

## Public Rights-of-Way

### (Curb Ramps)

| Intersection ID: 12682 | Main Street: MONTEZUMA_TL | Cross Street: PENCE_RD | Location: SE |

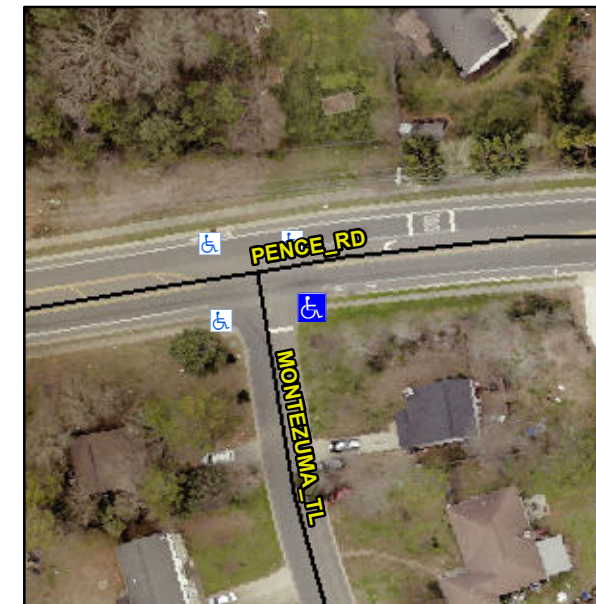
**Not Found, R304.5.3, R304.2.1, R304.2.2-Perp, R304.3.2-Para, R305, R302.7.2**

| Compliance | Description | Data | Compliance | Description | Data |
|---|---|---|---|---|---|
| Yes | Ramp Width (in) | 57.0 | No | Ramp XSlope (%) | 3.4 |
| No | Landing Length (in) | 35.0 | No | DWS Provided? | No |
| No | Landing Slope (%) | 4.4 | N/A | DWS Length (in) | N/A |
| No | Landing X Slope (%) | 3.2 | N/A | DWS Full Width? | No |
| No | Gutter Lip Ht (in) | 2.0 | No | Gutter X Slope (%) | 3.4 |

**Remove & Replace Curb Ramp With Two New Directional Ramps or Equivalent. Remove & Replace Gutter.**

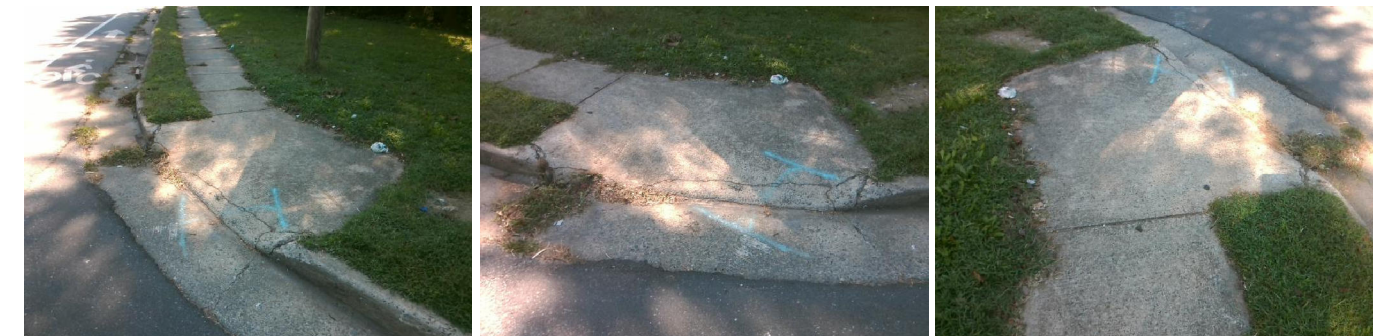
| Compliance | Description | Data | Compliance | Description | Data |
|---|---|---|---|---|---|
| N/A | Ramp Length (in) | 31.0 | Yes | Ramp Slope (%) | 6.0 |
