Access Compliance Report

Public Rights-of-Way

(Curb Ramps)

Intersection ID: 14843	Main Street: LYNDHURST_AV	Cross Street: MEACHAM_ST	Location: E
ADA ID: 12996C4AE505	Ramp Type: PerpDiag	Initial Pass/Fail: Fail	Overall Compliance: No
Severity Score: 8.75			
Codes/Mitigation Info/Possible Solution		Field Measurements/Component Compliance

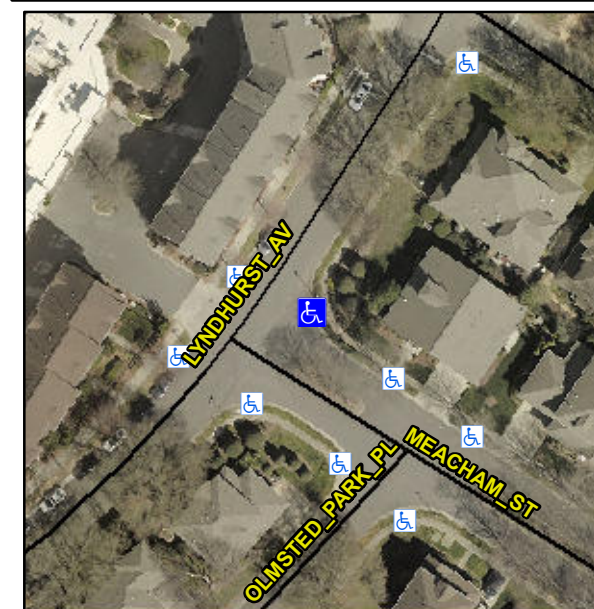
Not Found, R304.5.1

Compliance	Description	Data	Compliance	Description	Data
N/A	Ramp Length (in)	51.0	Yes	Ramp Slope (%)	5.7
No	Ramp Width (in)	43.0	Yes	Ramp XSlope (%)	1.5
N/A	Flare Type LT	N/A	N/A	Flare Type RT	N/A
N/A	Flare Slope LT (%)	N/A	N/A	Flare Slope RT (%)	N/A
N/A	Flare Traversable LT?	N/A	N/A	Flare Traversable RT?	N/A
N/A	Landing Length (in)	N/A	N/A	DWS Provided?	N/A
N/A	Landing Width (in)	N/A	N/A	DWS Contrast?	N/A
N/A	Landing Slope (%)	N/A	N/A	DWS Length (in)	N/A
N/A	Landing X Slope (%)	N/A	N/A	DWS Full Width?	N/A
N/A	Landing Curb? (Y/N)	N/A	N/A	DWS Offset (in)	N/A
N/A	Shared Landing?	N/A			
N/A	Gutter Ponding?	N/A	N/A	Gutter Slope (%)	N/A
N/A	Gutter Lip Ht (in)	N/A	N/A	Gutter X Slope (%)	N/A
N/A	Painted X Walk1?	No	N/A	Painted X Walk2?	No
	X Walk 1 Direction	To NW		X Walk 2 Direction	To SW
N/A	X Walk 1 Width (in)	N/A	N/A	X Walk 2 Width (in)	N/A
	X Walk 1 Slope (%)	2.1		X Walk 2 Slope (%)	0.2
	X Walk 1 X Slope (%)	0.0		X Walk 2 X Slope (%)	0.5

N/A	Ramp inside XWalk1?	N/A	N/A	Ramp inside XWalk2?	N/A
	Road Slope (%)	0.4	N/A	Clear Space?	N/A
	Road X Slope (%)	0.6	N/A	Clear Space to XWalk (in)	N/A
N/A	Any Obstructions?	N/A	N/A	Storm Grate/Utility Hazard?	N/A
	Obstruction Type			Storm Grate/Utility Type	
		N/A			N/A
		Yes		Surface Condition? (G/P)	Good

Remove & Replace Curb Ramp With Two New Directional Ramps or Equivalent.
