Access Compliance Report

Public Rights-of-Way (Curb Ramps)

Intersection ID: 54460	Main Street: STEELE_MEADOW_RD	Cross Street: FLINT_HILL_DR	Location: SW
ADA ID: 129C0E519EF4	Ramp Type: Perp	Initial Pass/Fail: Fail	Overall Compliance: No
Severity Score: 21.25			
Codes/Mitigation Info/Possible Solution		Field Measurements/Component Compliance

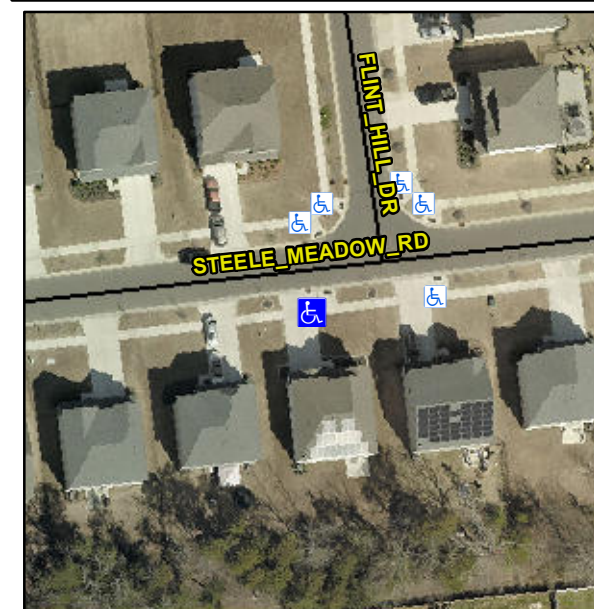
Not Found, R304.5.1, R304.2.2

Compliance	Description	Data	Compliance	Description	Data
N/A	Ramp Length (in)	95.0	No	Ramp Slope (%)	9.8
No	Ramp Width (in)	47.5	Yes	Ramp XSlope (%)	0.1
N/A	Flare Type LT	N/A	N/A	Flare Type RT	N/A
N/A	Flare Slope LT (%)	N/A	N/A	Flare Slope RT (%)	N/A
N/A	Flare Traversable LT?	N/A	N/A	Flare Traversable RT?	N/A
N/A	Landing Length (in)	N/A	N/A	DWS Provided?	N/A
N/A	Landing Width (in)	N/A	N/A	DWS Contrast?	N/A
N/A	Landing Slope (%)	N/A	N/A	DWS Length (in)	N/A
N/A	Landing X Slope (%)	N/A	N/A	DWS Full Width?	N/A
N/A	Landing Curb? (Y/N)	N/A	N/A	DWS Offset (in)	N/A
N/A	Shared Landing?	N/A			
N/A	Gutter Ponding?	N/A	N/A	Gutter Slope (%)	N/A
N/A	Gutter Lip Ht (in)	1.0	N/A	Gutter X Slope (%)	N/A
N/A	Painted X Walk1?	No	N/A	Painted X Walk2?	N/A
	X Walk 1 Direction	To N		X Walk 2 Direction	N/A
N/A	X Walk 1 Width (in)	N/A	N/A	X Walk 2 Width (in)	N/A
	X Walk 1 Slope (%)	2.1		X Walk 2 Slope (%)	N/A
	X Walk 1 X Slope (%)	2.1		X Walk 2 X Slope (%)	N/A

N/A	Ramp inside XWalk1?	N/A	N/A	Ramp inside XWalk2?	N/A
	Road Slope (%)	N/A	N/A	Clear Space?	N/A
	Road X Slope (%)	N/A	N/A	Clear Space to XWalk (in)	N/A
N/A	Any Obstructions?	N/A	N/A	Storm Grate/Utility Hazard?	N/A
	Obstruction Type			Storm Grate/Utility Type	
		N/A			N/A
		Yes		Surface Condition? (G/P)	Good

Possible Solutions:

Remove & Replace Entire Ramp.
