# Access Compliance Report

## Public Rights-of-Way

### (Curb Ramps)

Intersection ID: 12695	Main Street: S_CALDWELL_ST	Cross Street: E_TRADE_ST	Location:	N
ADA ID: 12A0F0987F45	Ramp Type: Perp	Initial Pass/Fail: Pass	Overall Compliance: No	Severity Score: 2.5

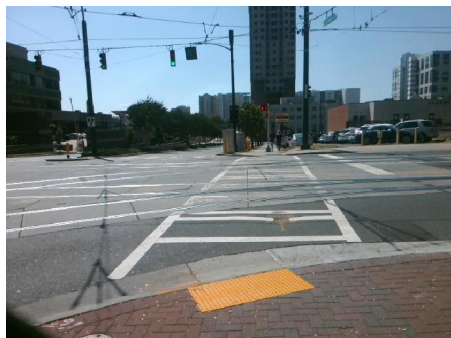
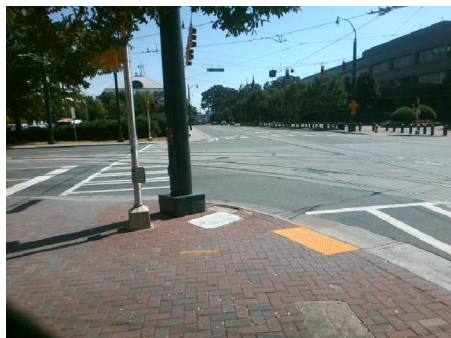
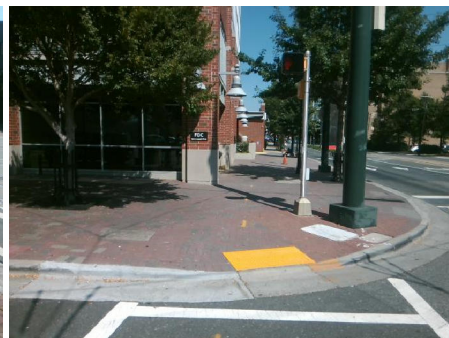
**Not Found, R304.5.3, R305.1.4**

Compliance	Description	Data	Compliance	Description	Data
N/A	Ramp Length (in)	66.0	Yes	Ramp Slope (%)	6.8
Yes	Ramp Width (in)	48.0	Yes	Ramp XSlope (%)	1.8
N/A	Flare Type LT	Sloped	N/A	Flare Type RT	N/A
N/A	Flare Slope LT (%)	8.3	N/A	Flare Slope RT (%)	5.9
N/A	Flare Traversable LT?	Yes	N/A	Flare Traversable RT?	No
Yes	Landing Length (in)	48.0	Yes	DWS Provided?	Yes
Yes	Landing Width (in)	48.0	Yes	DWS Contrast?	Yes
Yes	Landing Slope (%)	1.8	Yes	DWS Length (in)	24.5
No	Landing X Slope (%)	2.5	No	DWS Full Width?	No
N/A	Landing Curb? (Y/N)	No	Yes	DWS Offset (in)	1.5
N/A	Shared Landing?	No			
Yes	Gutter Ponding?	No	Yes	Gutter Slope (%)	2.1
Yes	Gutter Lip Ht (in)	0.0	No	Gutter X Slope (%)	2.2
N/A	Painted X Walk1?	Yes	N/A	Painted X Walk2?	N/A
	X Walk 1 Direction	To SW		X Walk 2 Direction	N/A
N/A	X Walk 1 Width (in)	110.0	N/A	X Walk 2 Width (in)	N/A
	X Walk 1 Slope (%)	2.3		X Walk 2 Slope (%)	N/A
	X Walk 1 X Slope (%)	1.1		X Walk 2 X Slope (%)	N/A

Yes	Ramp inside XWalk1?	Yes	N/A	Ramp inside XWalk2?	N/A
	Road Slope (%)	N/A	N/A	Clear Space?	Yes
	Road X Slope (%)	N/A	N/A	Clear Space to XWalk (in)	N/A
Yes	Any Obstructions?	No	Yes	Storm Grate/Utility Hazard?	No
	Obstruction Type			Storm Grate/Utility Type	
			N/A		N/A
			Yes	Surface Condition? (G/P)	Good

**Remove & Replace Entire Ramp.  
Remove & Replace Gutter.**

Total Cost: \$ 2600.00
