Access Compliance Report

Public Rights-of-Way

(Curb Ramps)

Intersection ID: 10445	Main Street: E_34TH_ST	Cross Street: N_MCDOWELL_ST	Location: S
ADA ID: 12AA3DA3A2DB	Ramp Type: Perp	Initial Pass/Fail: Fail	Overall Compliance: No
Severity Score: 13.75			
Codes/Mitigation Info/Possible Solution		Field Measurements/Component Compliance

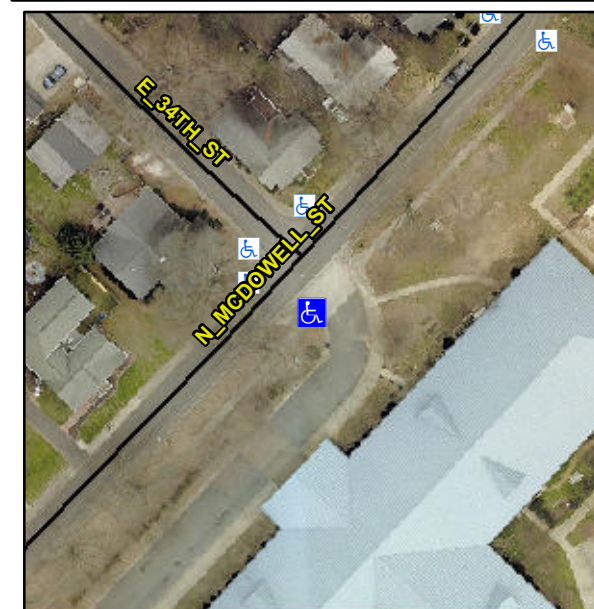
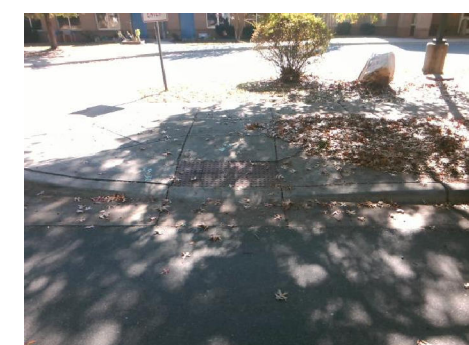
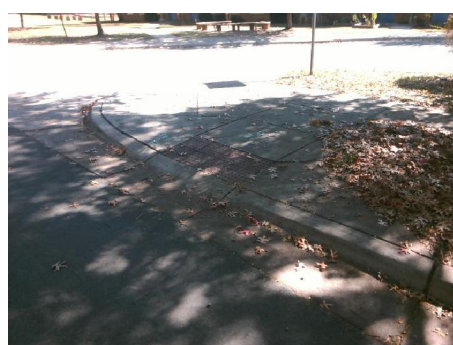
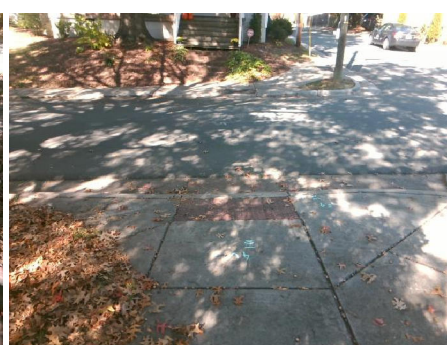
Not Found, R304.2.2, R304.5.3

Compliance	Description	Data	Compliance	Description	Data
N/A	Ramp Length (in)	24.5	No	Ramp Slope (%)	10.1
Yes	Ramp Width (in)	49.0	No	Ramp XSlope (%)	4.6
N/A	Flare Type LT	N/A	N/A	Flare Type RT	N/A
N/A	Flare Slope LT (%)	N/A	N/A	Flare Slope RT (%)	N/A
N/A	Flare Traversable LT?	N/A	N/A	Flare Traversable RT?	N/A
N/A	Landing Length (in)	N/A	N/A	DWS Provided?	N/A
N/A	Landing Width (in)	N/A	N/A	DWS Contrast?	N/A
N/A	Landing Slope (%)	N/A	N/A	DWS Length (in)	N/A
N/A	Landing X Slope (%)	N/A	N/A	DWS Full Width?	N/A
N/A	Landing Curb? (Y/N)	N/A	N/A	DWS Offset (in)	N/A
N/A	Shared Landing?	N/A			
N/A	Gutter Ponding?	Yes	N/A	Gutter Slope (%)	N/A
N/A	Gutter Lip Ht (in)	N/A	N/A	Gutter X Slope (%)	N/A
N/A	Painted X Walk1?	No	N/A	Painted X Walk2?	N/A
	X Walk 1 Direction	To NW		X Walk 2 Direction	N/A
N/A	X Walk 1 Width (in)	N/A	N/A	X Walk 2 Width (in)	N/A
	X Walk 1 Slope (%)	3.2		X Walk 2 Slope (%)	N/A
	X Walk 1 X Slope (%)	3.9		X Walk 2 X Slope (%)	N/A

N/A	Ramp inside XWalk1?	N/A	N/A	Ramp inside XWalk2?	N/A
	Road Slope (%)	N/A	N/A	Clear Space?	N/A
	Road X Slope (%)	N/A	N/A	Clear Space to XWalk (in)	N/A
N/A	Any Obstructions?	N/A	N/A	Storm Grate/Utility Hazard?	N/A
	Obstruction Type			Storm Grate/Utility Type	
		N/A			N/A
		Yes		Surface Condition? (G/P)	Good

Remove & Replace Entire Ramp.
