Access Compliance Report

Public Rights-of-Way

(Curb Ramps)

Intersection ID: 5213	Main Street: NORTH PARK_BV	Cross Street: REAMES_RD	Location: SE
ADA ID: 12B5B7C68787	Ramp Type: Combination1Diag	Initial Pass/Fail: Fail	Overall Compliance: No
Codes/Mitigation Info/Possible Solution		Field Measurements/Component Compliance	
Severity Score: 0

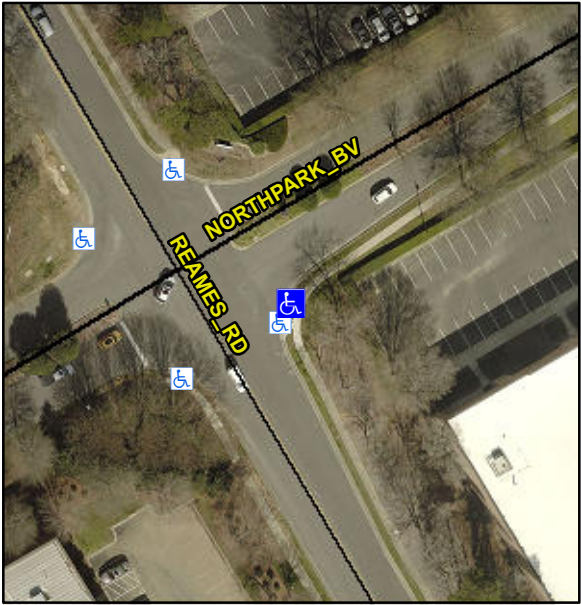
Possible Solutions:		Compliance	Description	Data	Compliance	Description	Data
	Remove & Replace Curb Ramp With Two New Directional Ramps or Equivalent.		N/A	Ramp Length LT (in)	56.0	N/A	Ramp Length RT (in)	56.0
			Yes	Ramp Width LT (in)	49.0	No	Ramp Width RT (in)	46.0
			Yes	Ramp Slope LT (%)	4.5	No	Ramp Slope RT (%)	8.9
			No	Ramp XSlope LT (%)	4.0	Yes	Ramp XSlope RT (%)	1.9
			N/A	Ramp Length (in)	54.0	No	Ramp Slope (%)	10.6
			Yes	Ramp Width (in)	55.5	No	Ramp XSlope (%)	7.2
			N/A	Flare Type LT	N/A	N/A	Flare Type RT	N/A
			N/A	Flare Slope LT (%)	N/A	N/A	Flare Slope RT (%)	N/A
			N/A	Flare Traversable LT?	N/A	N/A	Flare Traversable RT?	N/A
<p>Surveyor Notes:</p> <p>LT RP < 5%</p> <p>PROW/ADA:</p> <p>R304.5.1, R304.2.2, R304.5.3, R304.3.2</p>			N/A	Landing Length (in)	N/A	N/A	DWS Provided?	N/A
			N/A	Landing Width (in)	N/A	N/A	DWS Contrast?	N/A
			N/A	Landing Slope (%)	N/A	N/A	DWS Length (in)	N/A
			N/A	Landing X Slope (%)	N/A	N/A	DWS Full Width?	N/A

N/A	Landing Curb? (Y/N)	N/A	N/A	DWS Offset (in)	N/A
			N/A	Shared Landing?	N/A			
			N/A	Gutter Ponding?	N/A	N/A	Gutter Slope (%)	N/A
			N/A	Gutter Lip Ht (in)	N/A	N/A	Gutter X Slope (%)	N/A
			N/A	Painted X Walk1?	No	N/A	Painted X Walk2?	No
				X Walk 1 Direction	To N		X Walk 2 Direction	To W
<p>Street 1 Name</p> <p>Stop Condition-Street 1</p> <p>Street 2 Name</p> <p>Stop Condition-Street 2</p> <p>StopSign</p> <p>NORTH PARK BV</p> <p>None</p> <p>REAMES RD</p>				X Walk 1 Width (in)	N/A		X Walk 2 Width (in)	N/A
				X Walk 1 Slope (%)	4.3		X Walk 2 Slope (%)	4.5
				X Walk 1 X Slope (%)	1.6		X Walk 2 X Slope (%)	2.8
			N/A	Ramp inside XWalk1?	N/A	N/A	Ramp inside XWalk2?	N/A
				Road Slope (%)	4.4		Clear Space?	N/A
				Road X Slope (%)	3.7	N/A	Clear Space to XWalk (in)	N/A
						N/A	Any Obstruction?	N/A
							Obstruction Type	N/A
						N/A	Storm Grate/Utility Hazard?	N/A
							Storm Grate/Utility Type	N/A

<p>Total Cost:</p> <p>\$ 3200.00</p>			Yes	Surface Condition? (G/P)	Good			
				Curb Slope (%)	1.7
