Access Compliance Report

Public Rights-of-Way

(Curb Ramps)

Intersection ID: 28367	Main Street: SOUTHAMPTON COMMONS DR	Cross Street: TRAVIS GULCH DR	Location: NE
ADA ID: 12BAA9394F36	Ramp Type: PerpDiag	Initial Pass/Fail: Fail	Overall Compliance: No
Severity Score: 12.5			
Codes/Mitigation Info/Possible Solution		Field Measurements/Component Compliance

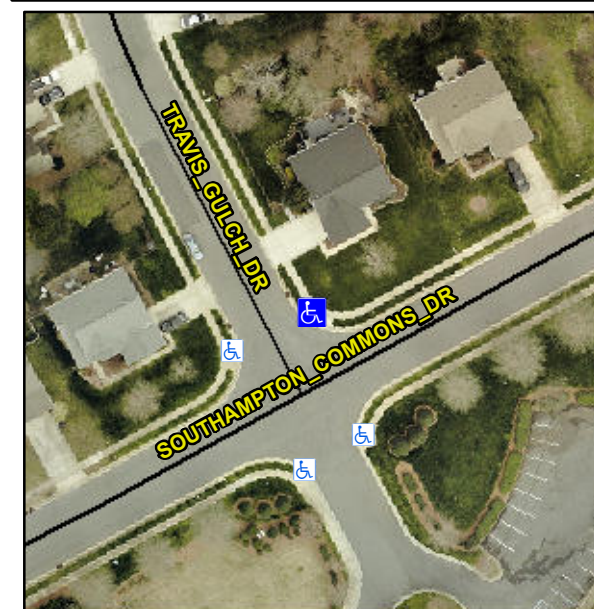
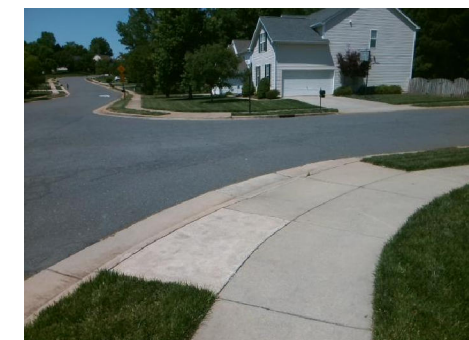
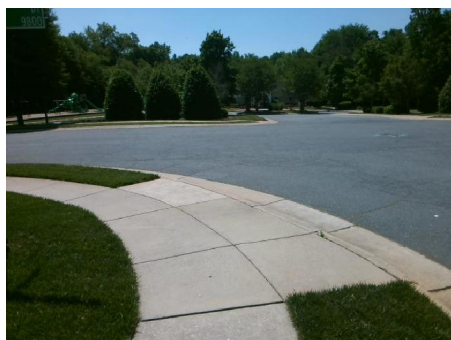
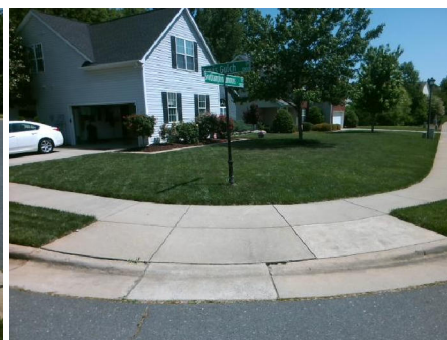
Not Found, R304.2.2

Compliance	Description	Data	Compliance	Description	Data
N/A	Ramp Length (in)	46.5	No	Ramp Slope (%)	8.7
Yes	Ramp Width (in)	73.0	Yes	Ramp XSlope (%)	1.7
N/A	Flare Type LT	N/A	N/A	Flare Type RT	N/A
N/A	Flare Slope LT (%)	N/A	N/A	Flare Slope RT (%)	N/A
N/A	Flare Traversable LT?	N/A	N/A	Flare Traversable RT?	N/A
N/A	Landing Length (in)	N/A	N/A	DWS Provided?	N/A
N/A	Landing Width (in)	N/A	N/A	DWS Contrast?	N/A
N/A	Landing Slope (%)	N/A	N/A	DWS Length (in)	N/A
N/A	Landing X Slope (%)	N/A	N/A	DWS Full Width?	N/A
N/A	Landing Curb? (Y/N)	N/A	N/A	DWS Offset (in)	N/A
N/A	Shared Landing?	N/A			
N/A	Gutter Ponding?	N/A	N/A	Gutter Slope (%)	N/A
N/A	Gutter Lip Ht (in)	N/A	N/A	Gutter X Slope (%)	N/A
N/A	Painted X Walk1?	No	N/A	Painted X Walk2?	No
	X Walk 1 Direction	To W		X Walk 2 Direction	To S
N/A	X Walk 1 Width (in)	N/A	N/A	X Walk 2 Width (in)	N/A
	X Walk 1 Slope (%)	2.7		X Walk 2 Slope (%)	0.8
	X Walk 1 X Slope (%)	1.4		X Walk 2 X Slope (%)	2.2

N/A	Ramp inside XWalk1?	N/A	N/A	Ramp inside XWalk2?	N/A
	Road Slope (%)	2.1	N/A	Clear Space?	N/A
	Road X Slope (%)	2.4	N/A	Clear Space to XWalk (in)	N/A
N/A	Any Obstructions?	N/A	N/A	Storm Grate/Utility Hazard?	N/A
	Obstruction Type			Storm Grate/Utility Type	
		N/A			N/A
			Yes	Surface Condition? (G/P)	Good

Remove & Replace Curb Ramp With Two New Directional Ramps or Equivalent.

Total Cost: \$ 3200.00
