Access Compliance Report Public Rights-of-Way (Curb Ramps)

Intersection ID: 12925 Main Street: S_CHURCH_ST Cross Street: W_CARSON_BV Location: NE **Severity Score: ADA ID: 12BB9D931D2D** Ramp Type: Directional1 Initial Pass/Fail: Fail **Overall Compliance: No** 12.5

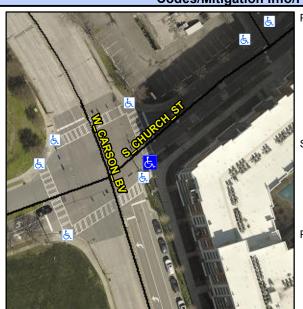
Field Measurements/Component Compliance									
Compl	iance Description	Data	Comp	liance	Description	Data			
N/A	Ramp Length (in)	92.0	N/A	Grad	e Break?	N/A			
Yes	Ramp Width (in)	89.0	N/A	Grad	e Break Slope (%)	0.0			
No	Ramp Slope (%)	9.2	N/A	Grad	e Break XSlope (%)	0.0			
Yes	Ramp XSlope (%)	0.6							
N/A	Flare Type LT	N/A	N/A	Flare	Type RT	N/A			
N/A	Flare Slope LT (%)	N/A	N/A	Flare	Slope RT (%)	0.0			
N/A	Flare Traversable LT?	N/A	N/A	Flare	Traversable RT?	N/A			
N/A	Landing Length (in)	0.0	N/A	DWS	Provided?	N/A			
N/A	Landing Width (in)	0.0	N/A	DWS	Contrast?	N/A			
N/A	Landing Slope (%)	0.0	N/A	DWS	Length (in)	N/A			
N/A	Landing X Slope (%)	0.0	N/A	DWS	Full Width?	N/A			
N/A	Landing Curb? (Y/N)	N/A	N/A	DWS	Offset LT (in)	N/A			
N/A	Shared Landing?	N/A	N/A	DWS	Offset RT (in)	N/A			
N/A	Gutter Ponding?	0.0	N/A	Gutte	er Slope (%)	N/A			
N/A	Gutter Lip Ht (in)	0.0	N/A	Gutte	r X Slope (%)	N/A			
N/A	Painted X Walk1?	Yes		Road	Slope (%)	1.0

X Walk 1 Direction	To NW		Road	X Slope (%)	0.7			
	X Walk 1 Width (in)	115.0		Clear	Space?	N/A			
	X Walk 1 Slope (%)	1.0	N/A	Clear	Space to XWalk (in)	N/A			
	X Walk 1 X Slope (%)	0.7	N/A	Storn	n Grate/Utility Hazard?	N/A			
N/A	Ramp inside XWalk1?	Yes		Storn	n Grate/Utility Type				
N/A	Any Obstructions?	N/A				N/A			
	Obstruction Type		Yes	Surfa	ce Condition? (G/P)	Good			
		N/A	N/A	Curb	Slope (%)	8.9

Possible Solutions:							
Remove & Replace Entire Ramp.							
Surveyor Notes:							
N/A							
PROW/ADA:							
R304.2.2
