Access Compliance Report

Public Rights-of-Way

(Curb Ramps)

Intersection ID: 29278	Main Street: OLD_VINE_CT	Cross Street: PAWLEY_DR	Location: NW
ADA ID: 12BBB4BF83F6	Ramp Type: PerpDiag	Initial Pass/Fail: Fail	Overall Compliance: No
		Severity Score: 8.75

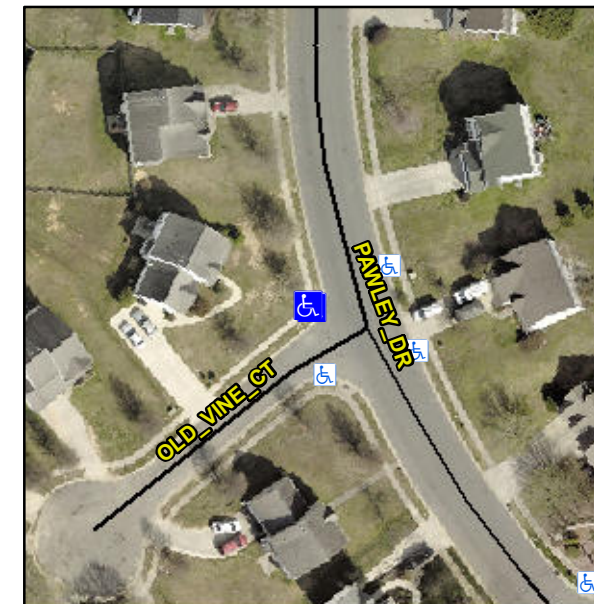
Not Found, R304.5.1

Compliance	Description	Data	Compliance	Description	Data
N/A	Ramp Length (in)	43.0	Yes	Ramp Slope (%)	5.1
No	Ramp Width (in)	47.5	Yes	Ramp XSlope (%)	1.8
N/A	Flare Type LT	N/A	N/A	Flare Type RT	N/A
N/A	Flare Slope LT (%)	N/A	N/A	Flare Slope RT (%)	N/A
N/A	Flare Traversable LT?	N/A	N/A	Flare Traversable RT?	N/A
N/A	Landing Length (in)	N/A	N/A	DWS Provided?	N/A
N/A	Landing Width (in)	N/A	N/A	DWS Contrast?	N/A
N/A	Landing Slope (%)	N/A	N/A	DWS Length (in)	N/A
N/A	Landing X Slope (%)	N/A	N/A	DWS Full Width?	N/A
N/A	Landing Curb? (Y/N)	N/A	N/A	DWS Offset (in)	N/A
N/A	Shared Landing?	N/A			
N/A	Gutter Ponding?	N/A	N/A	Gutter Slope (%)	N/A
N/A	Gutter Lip Ht (in)	N/A	N/A	Gutter X Slope (%)	N/A
N/A	Painted X Walk1?	No	N/A	Painted X Walk2?	No
	X Walk 1 Direction	To S		X Walk 2 Direction	To E
N/A	X Walk 1 Width (in)	N/A	N/A	X Walk 2 Width (in)	N/A
	X Walk 1 Slope (%)	0.1		X Walk 2 Slope (%)	3.5
	X Walk 1 X Slope (%)	3.1		X Walk 2 X Slope (%)	1.3

Remove & Replace Curb Ramp With Two New Directional Ramps or Equivalent.
