Access Compliance Report

Public Rights-of-Way

(Curb Ramps)

Intersection ID: 28272	Main Street: PEMSWOOD_ST	Cross Street: PURCHASE_ST	Location: W
ADA ID: 12BD4D3D1C63	Ramp Type: PerpDiag	Initial Pass/Fail: Fail	Overall Compliance: No
Severity Score: 12.5			
Codes/Mitigation Info/Possible Solution		Field Measurements/Component Compliance

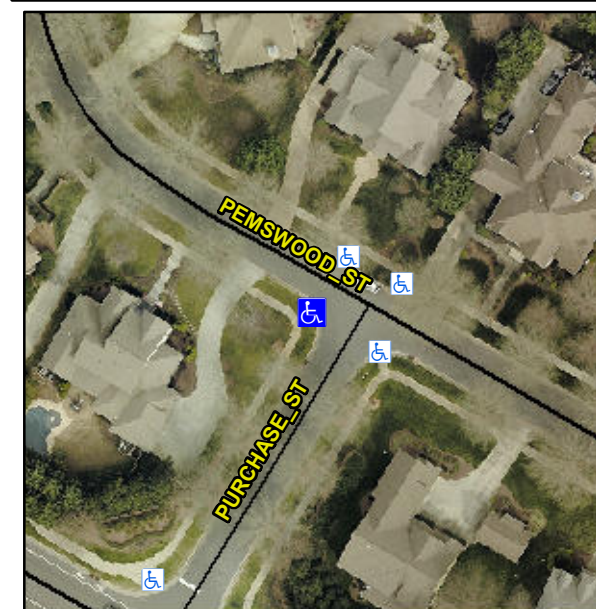
Compliance	Description	Data	Compliance	Description	Data
N/A	Ramp Length (in)	98.0	No	Ramp Slope (%)	8.5
Yes	Ramp Width (in)	53.0	Yes	Ramp XSlope (%)	0.1
N/A	Flare Type LT	N/A	N/A	Flare Type RT	N/A
N/A	Flare Slope LT (%)	N/A	N/A	Flare Slope RT (%)	N/A
N/A	Flare Traversable LT?	N/A	N/A	Flare Traversable RT?	N/A
N/A	Landing Length (in)	N/A	N/A	DWS Provided?	N/A
N/A	Landing Width (in)	N/A	N/A	DWS Contrast?	N/A
N/A	Landing Slope (%)	N/A	N/A	DWS Length (in)	N/A
N/A	Landing X Slope (%)	N/A	N/A	DWS Full Width?	N/A
N/A	Landing Curb? (Y/N)	N/A	N/A	DWS Offset (in)	N/A
N/A	Shared Landing?	N/A			
N/A	Gutter Ponding?	N/A	N/A	Gutter Slope (%)	N/A
N/A	Gutter Lip Ht (in)	N/A	N/A	Gutter X Slope (%)	N/A
N/A	Painted X Walk1?	No	N/A	Painted X Walk2?	No
	X Walk 1 Direction	To SE		X Walk 2 Direction	To NE
N/A	X Walk 1 Width (in)	N/A	N/A	X Walk 2 Width (in)	N/A
	X Walk 1 Slope (%)	0.3		X Walk 2 Slope (%)	2.4
	X Walk 1 X Slope (%)	2.3		X Walk 2 X Slope (%)	0.8

N/A	Ramp inside XWalk1?	N/A	N/A	Ramp inside XWalk2?	N/A
	Road Slope (%)	2.2	N/A	Clear Space?	N/A
	Road X Slope (%)	3.5	N/A	Clear Space to XWalk (in)	N/A
N/A	Any Obstructions?	N/A	N/A	Storm Grate/Utility Hazard?	N/A
	Obstruction Type			Storm Grate/Utility Type	
		N/A			N/A
			Yes	Surface Condition? (G/P)	Good

Possible Solutions:

Remove & Replace Curb Ramp With Two New Directional Ramps or Equivalent.

R304.2.2

Total Cost: \$ 3200.00
