Access Compliance Report

Public Rights-of-Way

(Curb Ramps)

Intersection ID: 47453	Main Street: WOOD_DUCK_CROSSING_DR	Cross Street: WHISTLING_SWAN_RD	Location: NW
ADA ID: 12C309B5D313	Ramp Type: PerpDiag	Initial Pass/Fail: Fail	Overall Compliance: No
Severity Score: 10			
Codes/Mitigation Info/Possible Solution		Field Measurements/Component Compliance

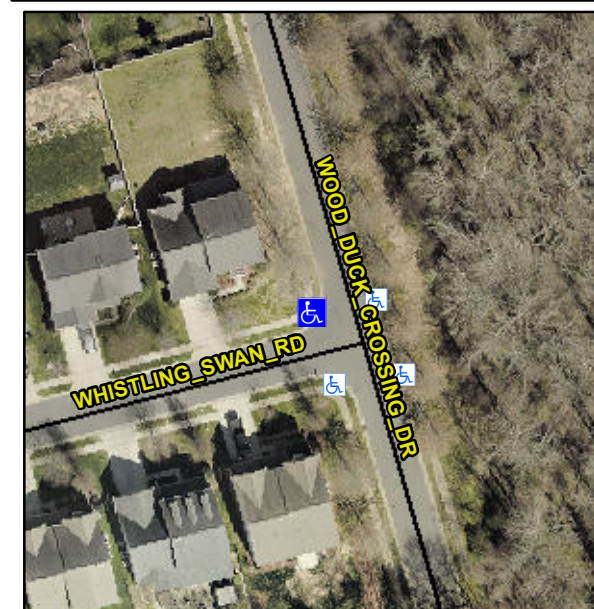
Not Found, R304.5.1, R304.5.3

Compliance	Description	Data	Compliance	Description	Data
N/A	Ramp Length (in)	95.0	Yes	Ramp Slope (%)	6.0
No	Ramp Width (in)	47.0	No	Ramp XSlope (%)	2.2
N/A	Flare Type LT	N/A	N/A	Flare Type RT	N/A
N/A	Flare Slope LT (%)	N/A	N/A	Flare Slope RT (%)	N/A
N/A	Flare Traversable LT?	N/A	N/A	Flare Traversable RT?	N/A
N/A	Landing Length (in)	N/A	N/A	DWS Provided?	N/A
N/A	Landing Width (in)	N/A	N/A	DWS Contrast?	N/A
N/A	Landing Slope (%)	N/A	N/A	DWS Length (in)	N/A
N/A	Landing X Slope (%)	N/A	N/A	DWS Full Width?	N/A
N/A	Landing Curb? (Y/N)	N/A	N/A	DWS Offset (in)	N/A
N/A	Shared Landing?	N/A			
N/A	Gutter Ponding?	N/A	N/A	Gutter Slope (%)	N/A
N/A	Gutter Lip Ht (in)	N/A	N/A	Gutter X Slope (%)	N/A
N/A	Painted X Walk1?	No	N/A	Painted X Walk2?	No
	X Walk 1 Direction	To S		X Walk 2 Direction	To E
N/A	X Walk 1 Width (in)	N/A	N/A	X Walk 2 Width (in)	N/A
	X Walk 1 Slope (%)	2.5		X Walk 2 Slope (%)	4.3
	X Walk 1 X Slope (%)	0.3		X Walk 2 X Slope (%)	1.6

N/A	Ramp inside XWalk1?	N/A	N/A	Ramp inside XWalk2?	N/A
	Road Slope (%)	0.1	N/A	Clear Space?	N/A
	Road X Slope (%)	3.9	N/A	Clear Space to XWalk (in)	N/A
N/A	Any Obstructions?	N/A	N/A	Storm Grate/Utility Hazard?	N/A
	Obstruction Type			Storm Grate/Utility Type	
		N/A			N/A
		Yes		Surface Condition? (G/P)	Good

Remove & Replace Curb Ramp With Two New Directional Ramps or Equivalent.
