Access Compliance Report

Public Rights-of-Way

(Curb Ramps)

Intersection ID: 50928	Main Street: GREAT_FUTURE_DR	Cross Street: MARVIN_RD	Location: SW
ADA ID: 12D4A5861E1F	Ramp Type: Perp	Initial Pass/Fail: Fail	Overall Compliance: No
			Severity Score: 12.5

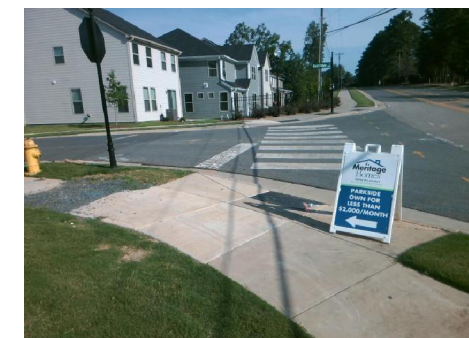
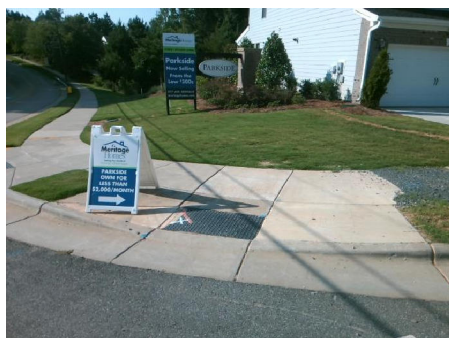
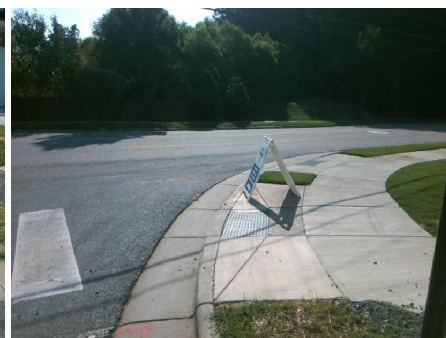
Not Found, R304.5.3

Compliance	Description	Data	Compliance	Description	Data
N/A	Ramp Length (in)	46.0	Yes	Ramp Slope (%)	5.5
Yes	Ramp Width (in)	50.0	No	Ramp XSlope (%)	5.2
N/A	Flare Type LT	N/A	N/A	Flare Type RT	N/A
N/A	Flare Slope LT (%)	N/A	N/A	Flare Slope RT (%)	N/A
N/A	Flare Traversable LT?	N/A	N/A	Flare Traversable RT?	N/A
N/A	Landing Length (in)	N/A	N/A	DWS Provided?	N/A
N/A	Landing Width (in)	N/A	N/A	DWS Contrast?	N/A
N/A	Landing Slope (%)	N/A	N/A	DWS Length (in)	N/A
N/A	Landing X Slope (%)	N/A	N/A	DWS Full Width?	N/A
N/A	Landing Curb? (Y/N)	N/A	N/A	DWS Offset (in)	N/A
N/A	Shared Landing?	N/A			
N/A	Gutter Ponding?	N/A	N/A	Gutter Slope (%)	N/A
N/A	Gutter Lip Ht (in)	N/A	N/A	Gutter X Slope (%)	N/A
N/A	Painted X Walk1?	Yes	N/A	Painted X Walk2?	N/A
	X Walk 1 Direction	To NW		X Walk 2 Direction	N/A
N/A	X Walk 1 Width (in)	120.0	N/A	X Walk 2 Width (in)	N/A
	X Walk 1 Slope (%)	5.8		X Walk 2 Slope (%)	N/A
	X Walk 1 X Slope (%)	3.5		X Walk 2 X Slope (%)	N/A

N/A	Ramp inside XWalk1?	Yes	N/A	Ramp inside XWalk2?	N/A
	Road Slope (%)	N/A	N/A	Clear Space?	N/A
	Road X Slope (%)	N/A	N/A	Clear Space to XWalk (in)	N/A
N/A	Any Obstructions?	N/A	N/A	Storm Grate/Utility Hazard?	N/A
	Obstruction Type			Storm Grate/Utility Type	
		N/A			N/A
			Yes	Surface Condition? (G/P)	Good

Remove & Replace Entire Ramp.

Total Cost: \$ 1850.00
